# FACILITY CONDITION ASSESSMENT

FACILITY CONDITION ASSESSMENT  
OF  
DEDHAM - DEDHAM HIGH SCHOOL  
140 WHITING AVENUE  
DEDHAM, MASSACHUSETTS 02026

November 17, 2016

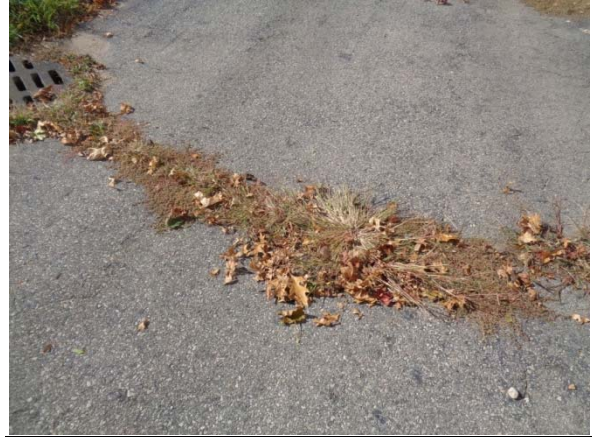
PHOTO #10: CRACKING ACROSS A SECTION OF ASPHALT PAVED SIDEWALK

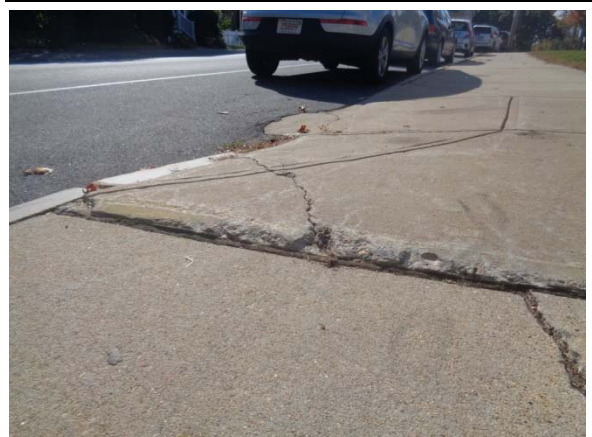
PHOTO #12: DAMAGED CONCRETE AND A POTENTIAL TRIP HAZARD AT A SECTION OF SIDEWALK ADJACENT TO MAIN ENTRANCE

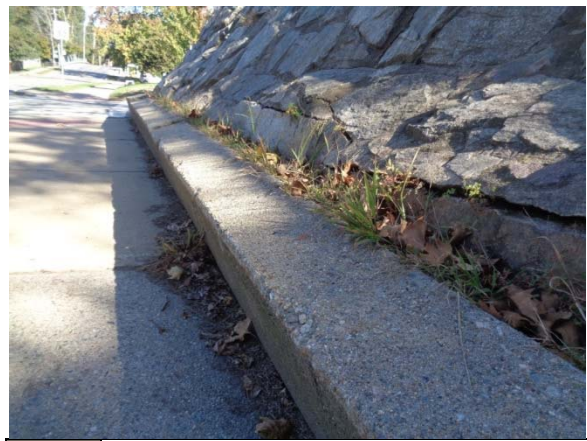
PHOTO #14: A SECTION OF DAMAGED RETAINING WALL AND DISPLACED CONCRETE CURB AT THE SITE PERIMETER

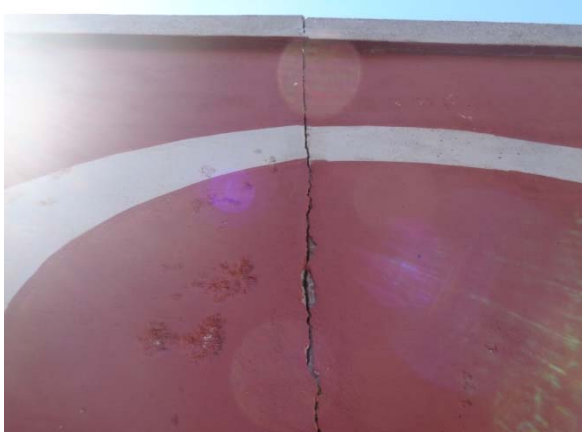
PHOTO #15: A VERTICAL CRACK AT THE RETAINING WALL ADJACENT TO THE GYMNASIUM

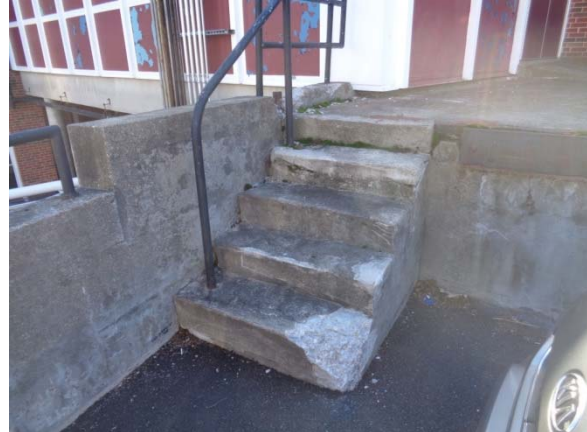
PHOTO #16: DAMAGED CONCRETE STAIRS AT THE LOADING DOCK

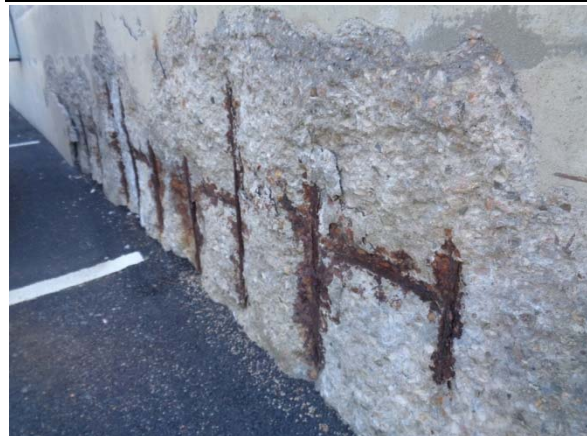
PHOTO #18: DETERIORATED CONCRETE AND EXPOSED STEEL REINFORCING AT THE EXTERIOR FACE OF THE FOUNDATION WALL

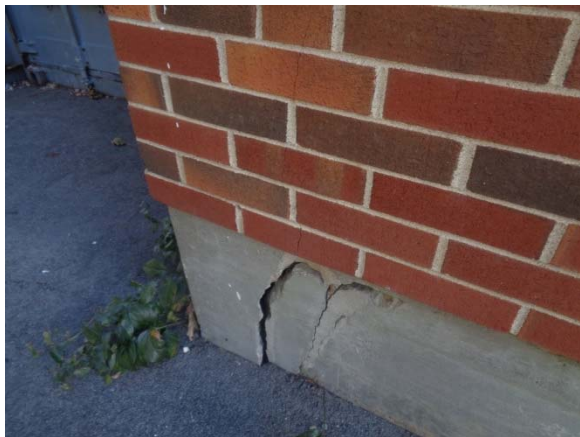
PHOTO #19: *CRACKED CONCRETE FOUNDATION AT A BUILDING CORNER*

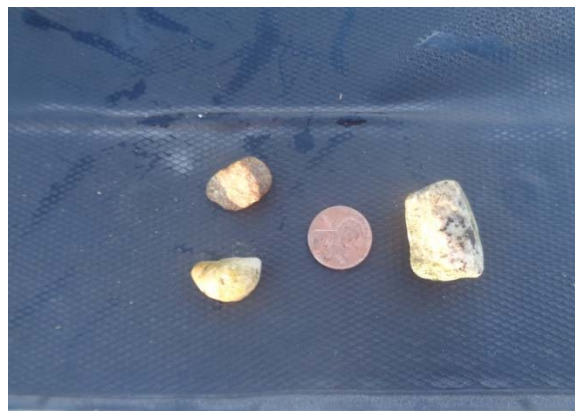
PHOTO #24: *LOOSE GRAVEL SURFACING*

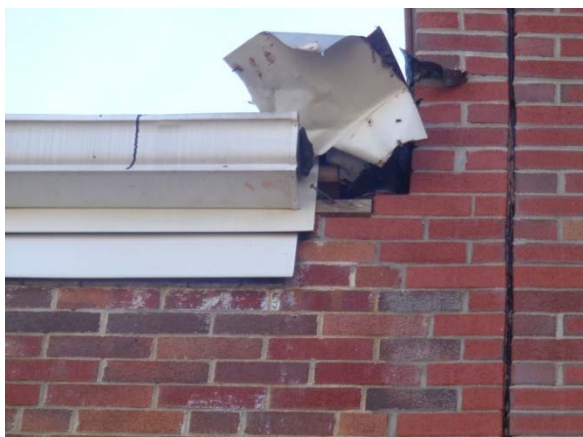
PHOTO #25: AREA OF DAMAGED ROOF FLASHING AT THE FITNESS CENTER ROOF

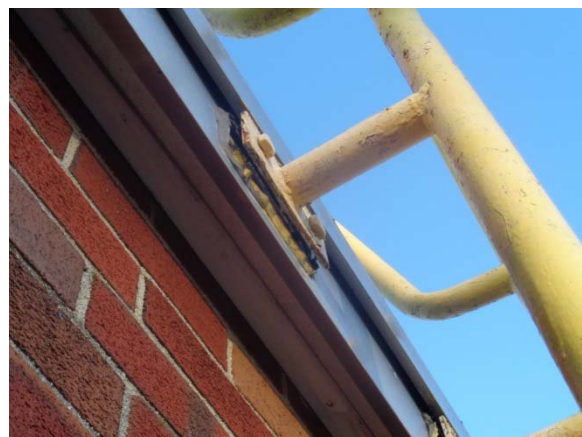
PHOTO #26: DETACHED ROOF LADDER

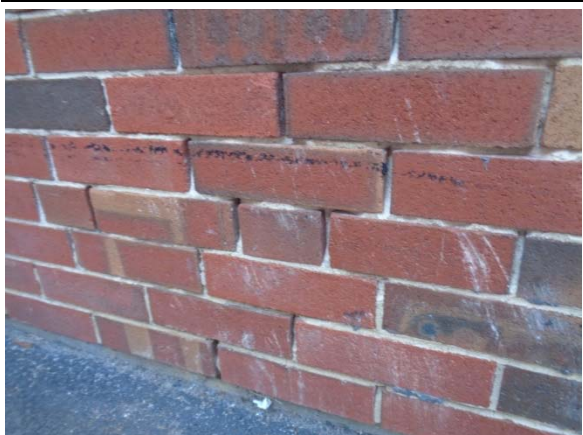
PHOTO #27: DETERIORATED MORTAR JOINTS

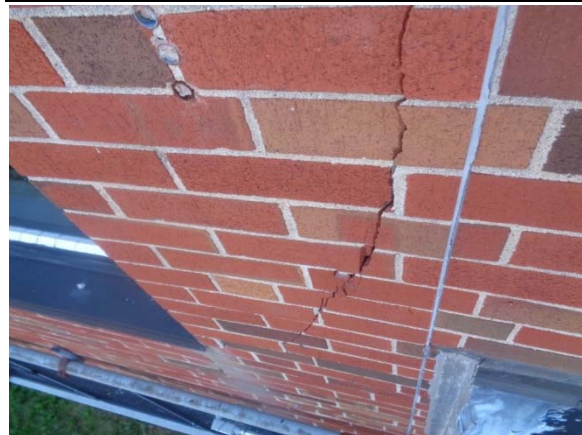
PHOTO #28: CRACKED BRICK MASONRY EXTERIOR WALL

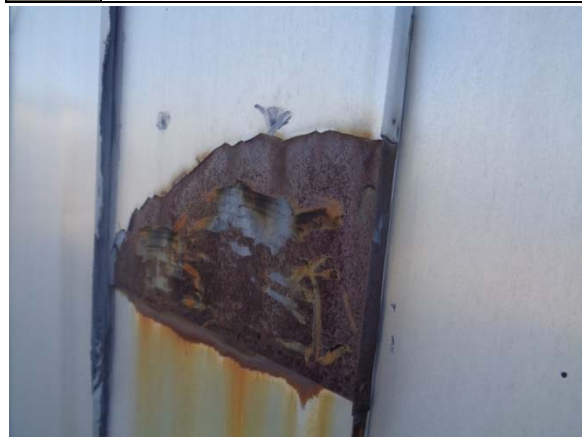
PHOTO #30: CORRODED EXTERIOR METAL WALL

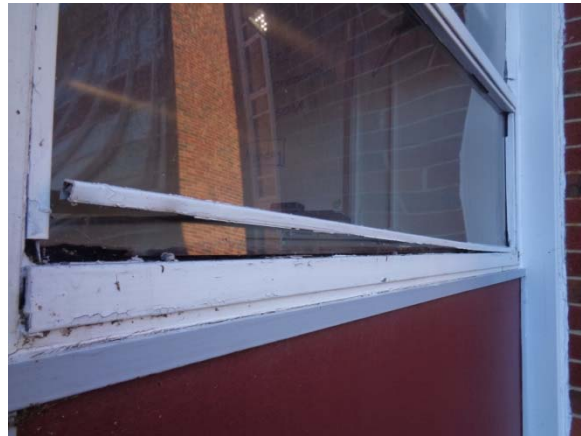
PHOTO #32: DAMAGED CURTAIN WALL WINDOW FRAME

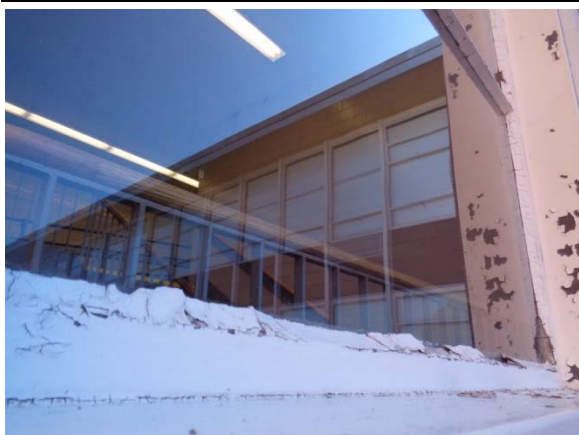
PHOTO #33: DETERIORATED CURTAIN WALL GLAZING PUTTY AND FAILED PAINT

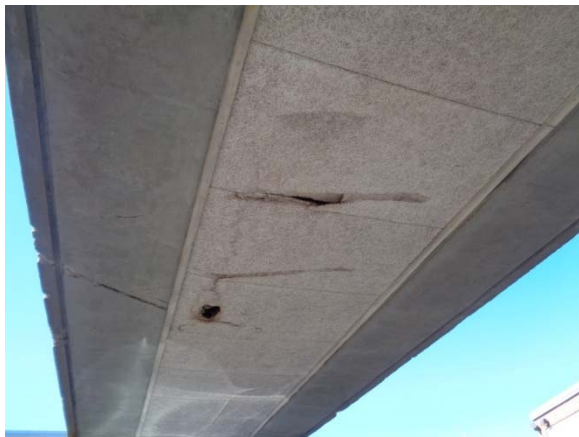
PHOTO #37: DAMAGED WOOD FIBER SOFFIT AT THE UNDERSIDE OF THE ELEVATED WALKWAY

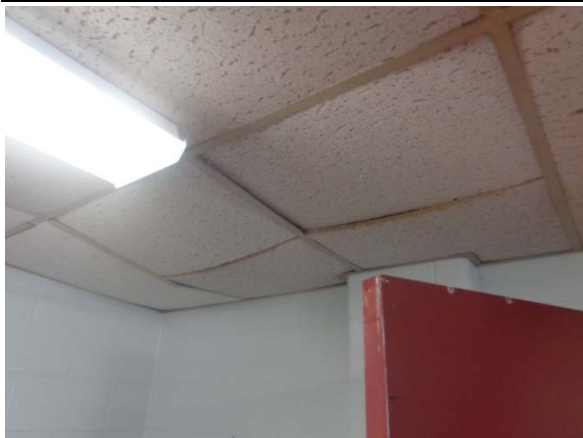
PHOTO #57: AREA OF POORLY-FITTING CEILING TILES
