FACILITY CONDITION ASSESSMENT

FACILITY CONDITION ASSESSMENT
OF THE
DEDHAM-DEDHAM MIDDLE SCHOOL
70 WHITING AVENUE
DEDHAM, MASSACHUSETTS 02026

December 27, 2016

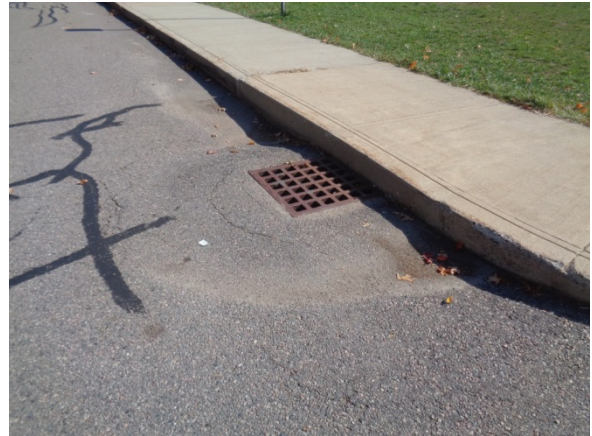
PHOTO #8: DEPRESSED ASPHALT PAVEMENT AT A CATCH BASIN

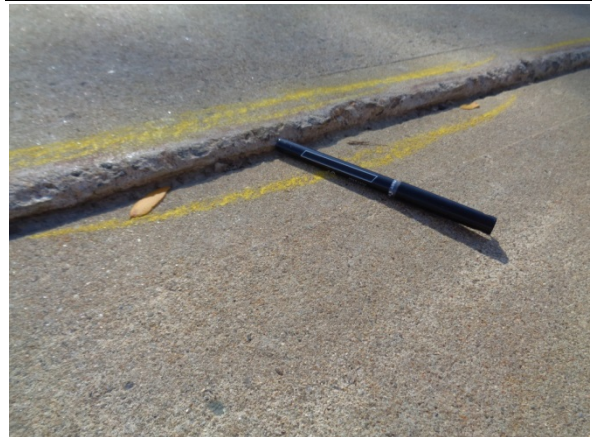
PHOTO #10: SETTLED SECTION OF CONCRETE SIDEWALK – POTENTIAL TRIPPING HAZARD

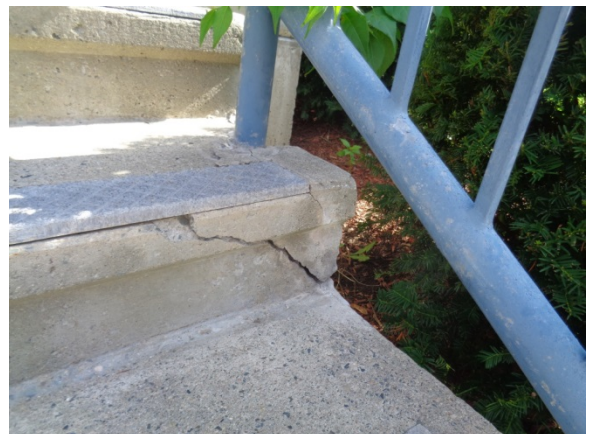
PHOTO #12: CRACKED CONCRETE STAIR AT A HANDRAIL BASE

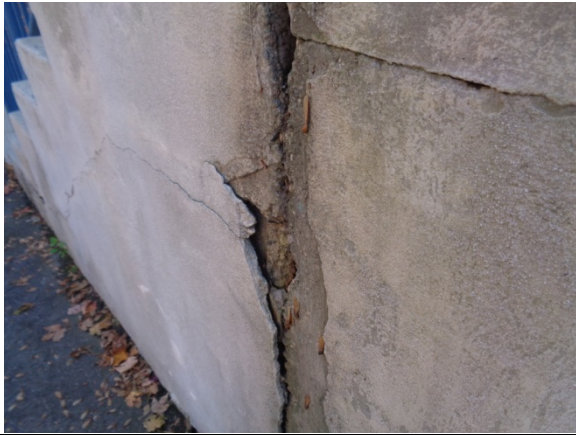
PHOTO #13: CRACKED CONCRETE AT THE NORTH LOADING DOCK

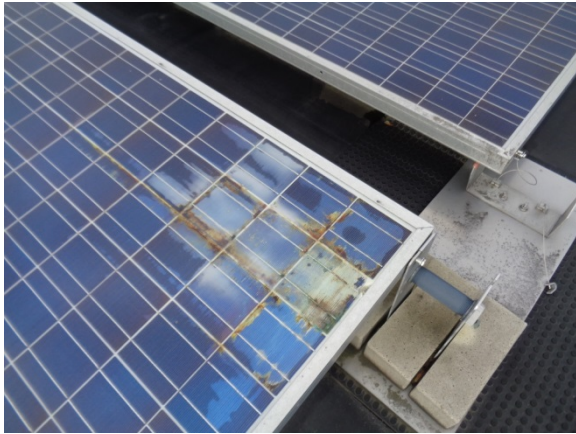
PHOTO #19: DAMAGED SOLAR PANEL

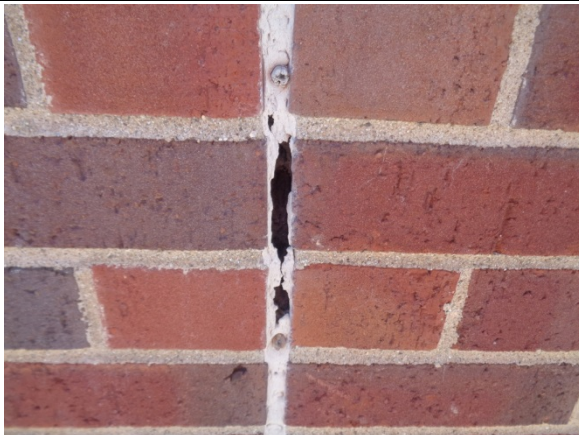
PHOTO #21: DETERIORATED BRICK MASONRY EXPANSION JOINT

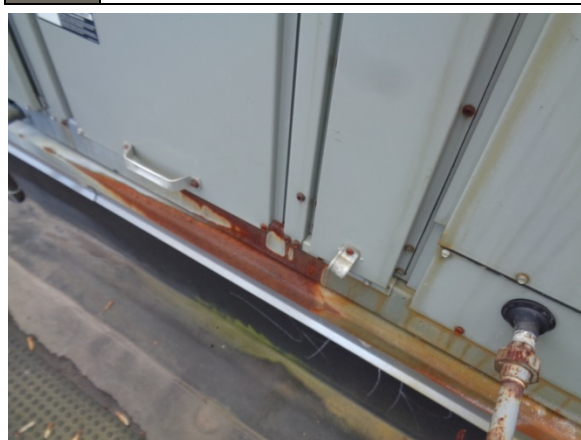
PHOTO #30: MINOR CORROSION AT THE BASE OF A ROOFTOP PACKAGE UNIT
