# FACILITY CONDITION ASSESSMENT

FACILITY CONDITION ASSESSMENT  
OF  
DEDHAM-AVERY ELEMENTARY SCHOOL  
366 HIGH STREET  
DEDHAM, MASSACHUSETTS 02026

November 30, 2016

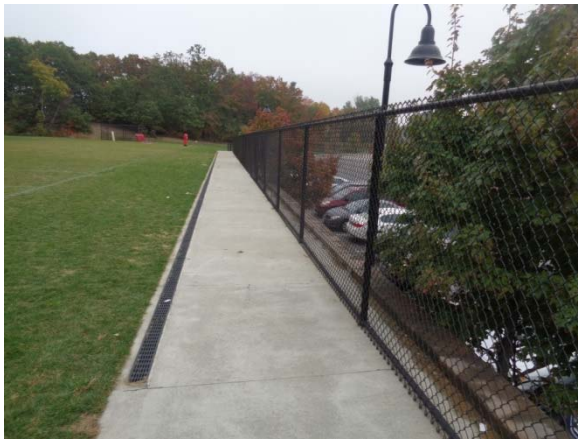
PHOTO #9: CHAIN LINK FENCING AND CONCRETE SIDEWALK

- Asphalt seal and stripe
- Chain link replacement (older than date of construction)
- Sport court seal

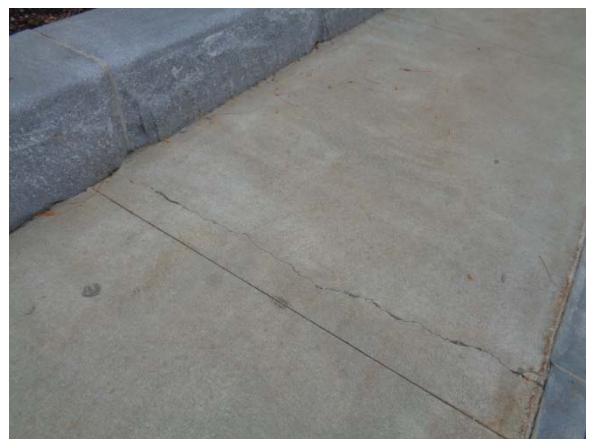
PHOTO #10: MINOR CRACKING AT A SECTION OF CONCRETE SIDEWALK

- The concrete sidewalk at the main driveway has isolated areas of minor cracks. Concrete cracks should be repaired.
- A minor portion of the stone pavers adjacent to the main building entrance are uneven, creating a potential trip hazard. Immediate repair of the pavers is required to mitigate potential safety concerns.
- The asphalt pavement has isolated areas of alligator cracking, and general weathering of the pavement surface. Sealing, striping and crack repair is recommended to maintain the integrity of the paving system.

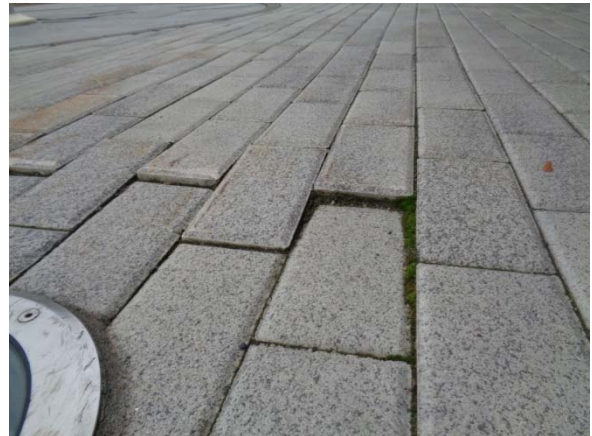
PHOTO #12: UNEVEN BRICK PAVERS ARE A POTENTIAL TRIP HAZARD
