FACILITY CONDITION ASSESSMENT

FACILITY CONDITION ASSESSMENT
OF
DEDHAM-OAKDALE ELEMENTARY SCHOOL
147 CEDAR STREET
DEDHAM, MASSACHUSETTS 02026

EMG
10461 Mill Run Circle, Suite 1100
Owings Mills, Maryland 21117
800.733.0660
www.EMGcorp.com

December 27, 2016

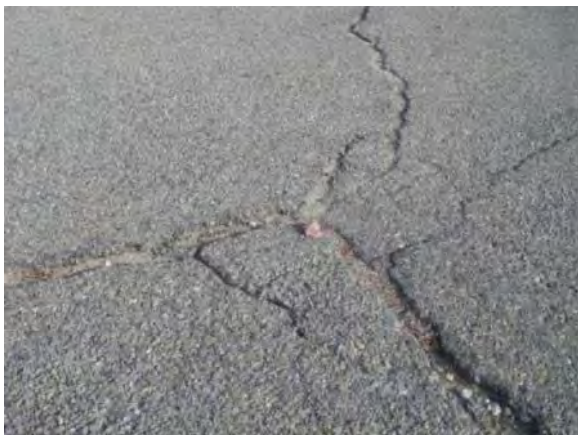
- The west side and the courtyard pavement needs attention and this is a high cost immediate repair. The pavement can be cut and patched or completely milled and overlaid.

PHOTO #9: WEST PARKING LOT ASPHALT DETERIORATION

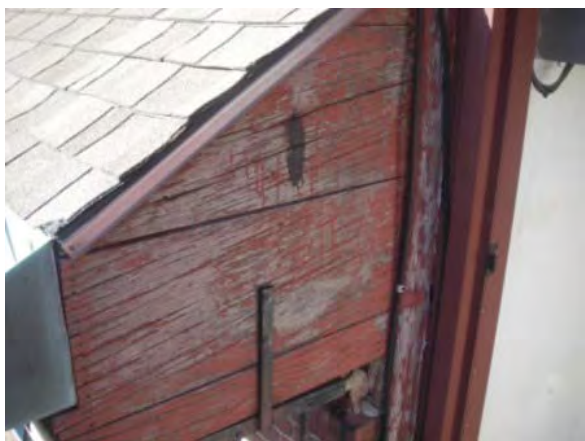
PHOTO #25: 1902 BUILDING FIRE ESCAPE WALKOUT NEEDS WORK

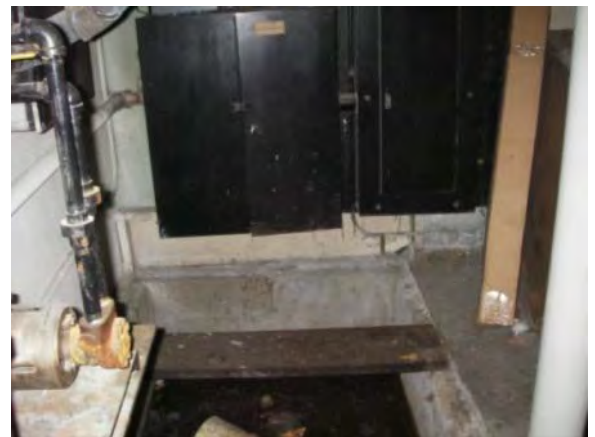
PHOTO #52: 1952 WING BOILER ROOM ELECTRIC PANELS AND OPEN PIT HAZARD

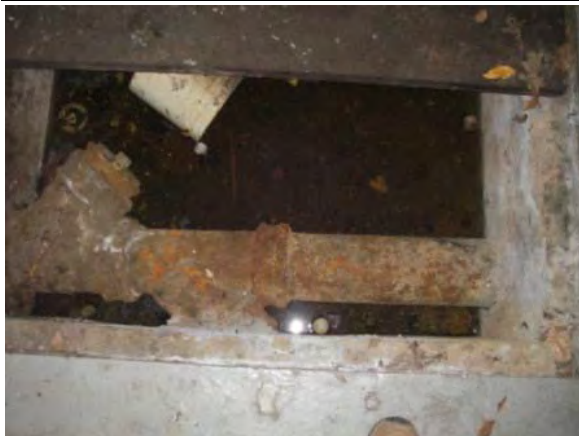
PHOTO #53: 1952 WING SUMP PIT IN FRONT OF ELECTRICAL PANELS

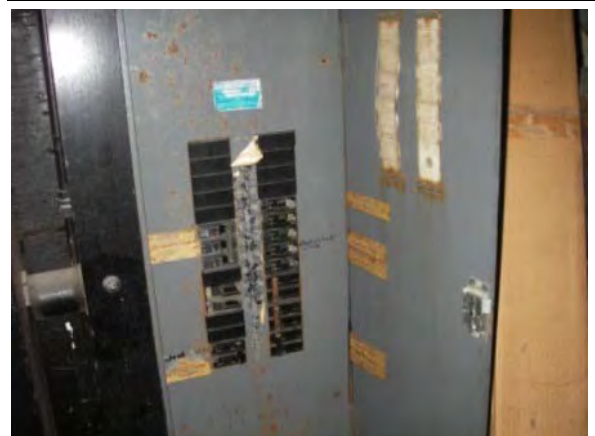
PHOTO #54: 1952 WING BOILER ROOM OLDER ELECTRICAL PANEL

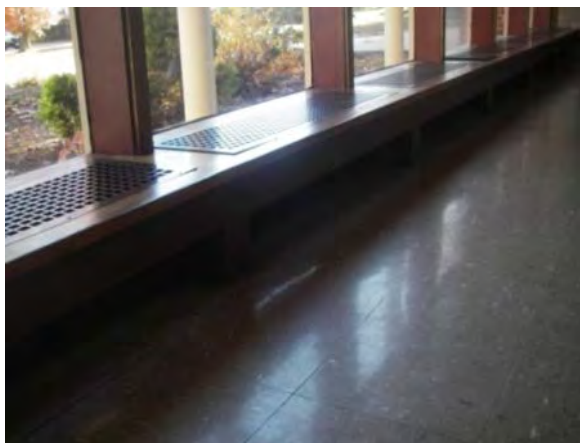
PHOTO #79: 1952 WING LOBBY LEAKING AND UNUSED STEAM RADIATORS

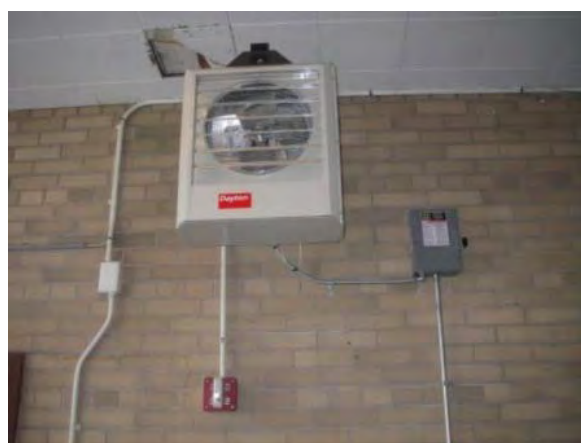
PHOTO #80: 1952 WING LOBBY UNIT HEATER OFFSETS FAILED RADIATORS

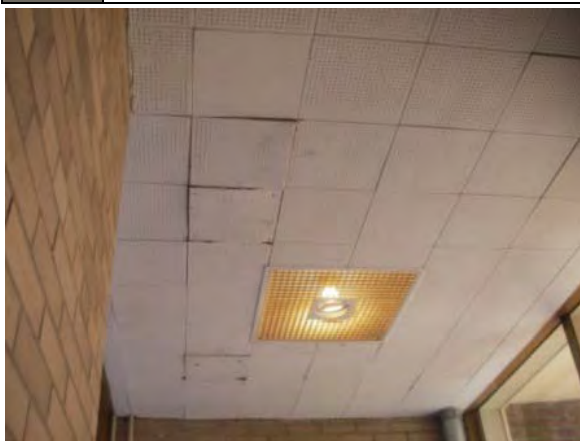
PHOTO #81: 1952 WING LOBBY CEILING TILES IN POOR CONDITION

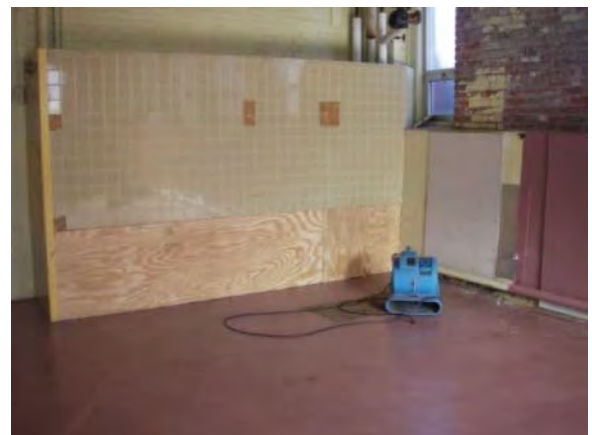
PHOTO #108: 1902 BUILDING BASEMENT GIRL'S RESTROOM UNFINISHED REPAIRS

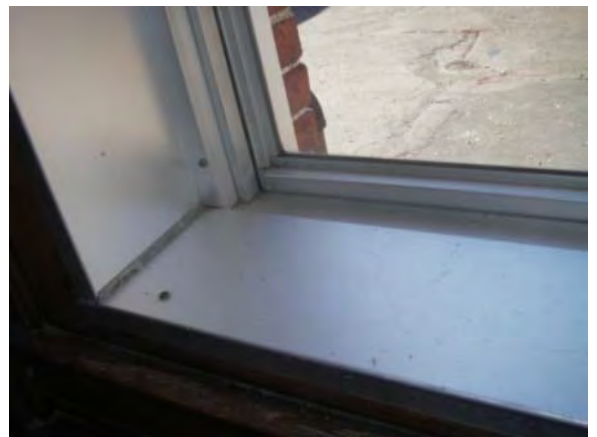
- The windows are antiquated, energy-inefficient units with single-pane glazing. Storm windows are not present anywhere. Some of the windows are difficult to open and close. The windows are cannot be maintained. This is the most significant building envelope equipment that can improve comfort and provide significant savings on heating costs. Window replacement throughout the buildings is recommended.

PHOTO #118: 1902 BUILDING ORIGINAL ALUMINUM WINDOW FRAME & SINGLE GLAZE

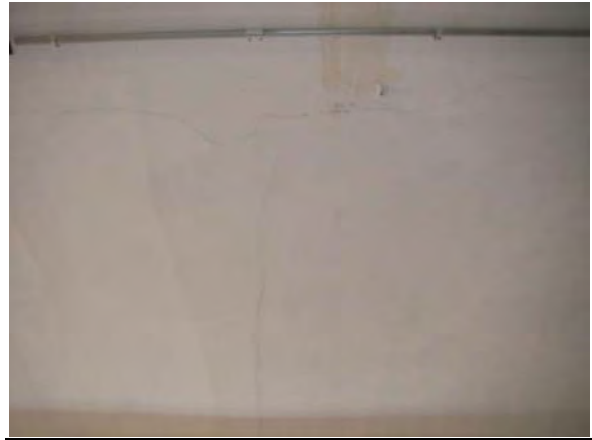
PHOTO #122: 1902 BUILDING CLASSROOM CRACKED AND STAINED CEILING

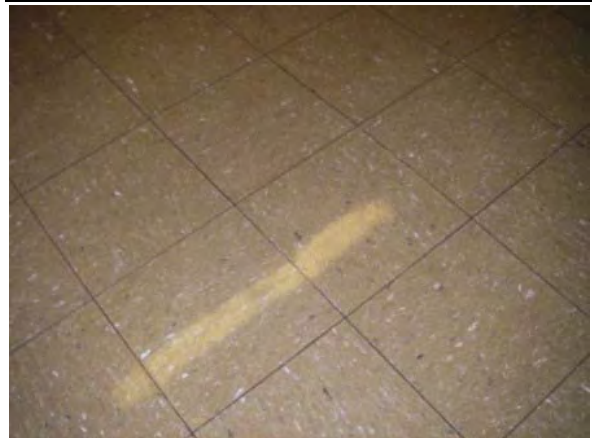
- The interior vinyl tile finishes in the 1902 original building are old, worn, and outdated. The tiles can no longer be re-coated and buffed for a sealed surface that shines. Recommend replacing floors that are worn out.

PHOTO #124: 1902 BUILDING WORN VINYL FLOOR TILE

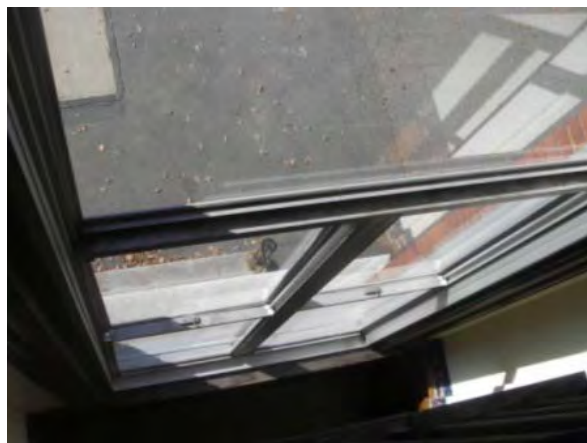
- Exterior windows are a high cost immediate repair. There is no question that the school has gotten its money's worth out of these windows. The windows are drafty because they do not seal well. The single pane glazing provides minimal insulation from the cold. Replacement windows will increase comfort and significantly reduce heating costs.

PHOTO #127: 1902 BUILDING ORIGINAL ALUMINUM WINDOW FRAME AND GLASS

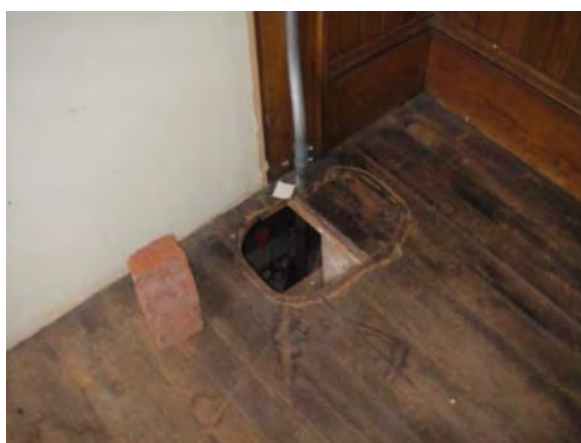
PHOTO #128: 1902 BUILDING 3RD FLOOR HALL REPAIR NEEDED

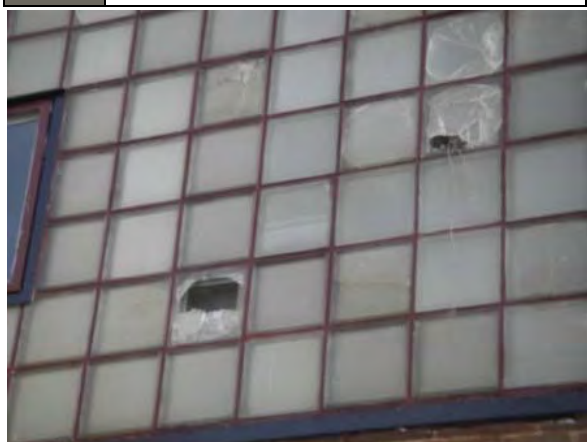
PHOTO #135: GYM BROKEN WINDOWS

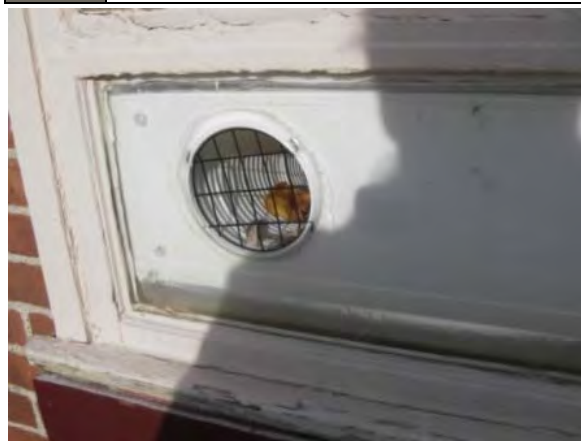
PHOTO #138: 1952 WING CLASSROOM HVAC VENT NEEDS A MOUSE/INSECT SCREEN
