FACILITY CONDITION ASSESSMENT

FACILITY CONDITION ASSESSMENT
OF
DEDHAM – ECEC CAPEN SCHOOL
322 SPRAGUE STREET
DEDHAM, MASSACHUSETTS 02026

121711.16R000-005.322

December 12, 2016

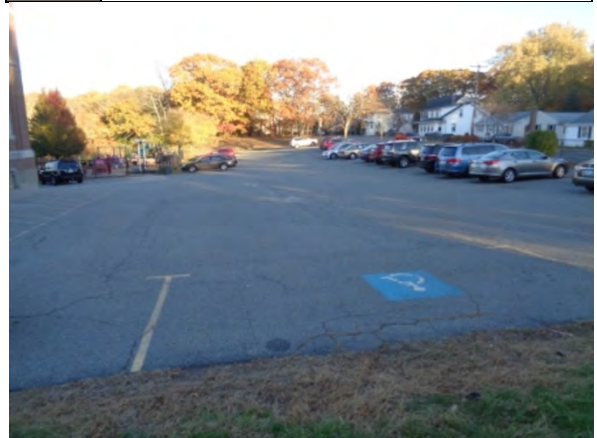
PHOTO #6: PARKING LOT LOOKING EAST

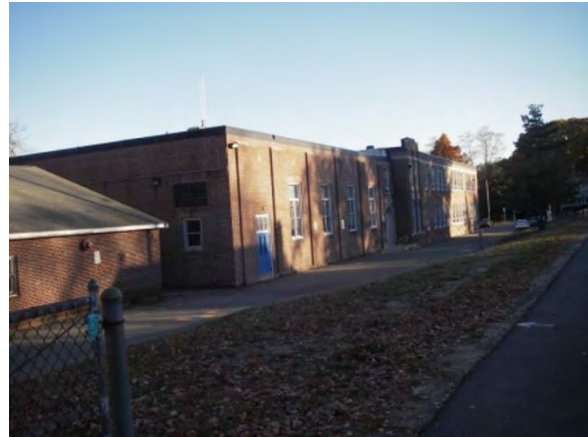
PHOTO #12: WEST FACE OF BUILDING

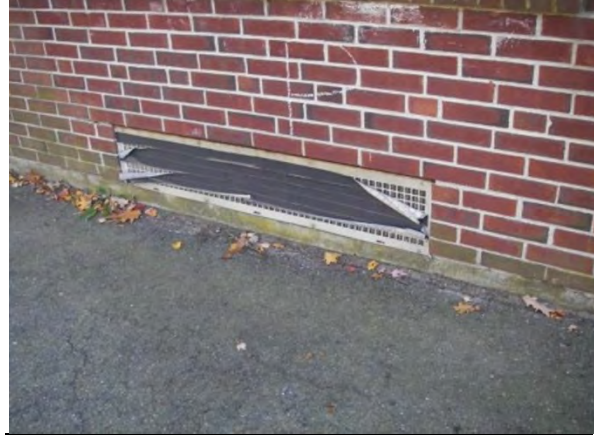
PHOTO #18: REAR BLDG EXTENSION UNIT VENT FRESH AIR VENT BLOCKED

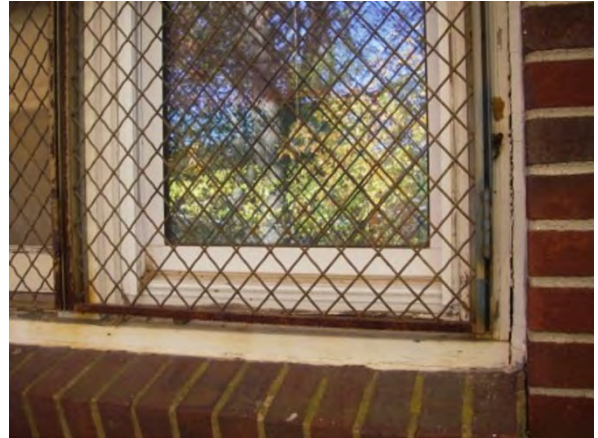
PHOTO #20: REAR BLDG EXTENSION RUSTED
WINDOW INTRUSION PROTECTION

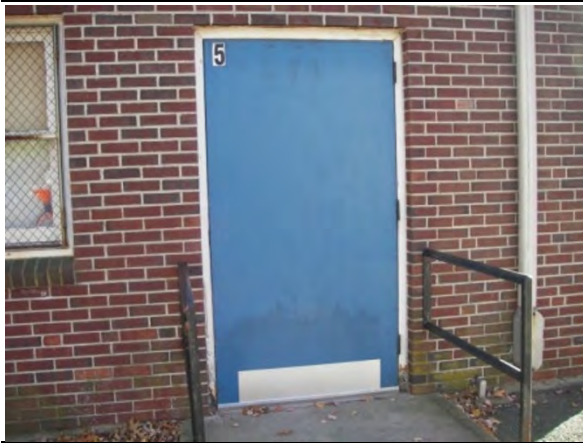
PHOTO #21: REAR BUILDING EXTENSION DOOR
AND CORRODED DOOR FRAME

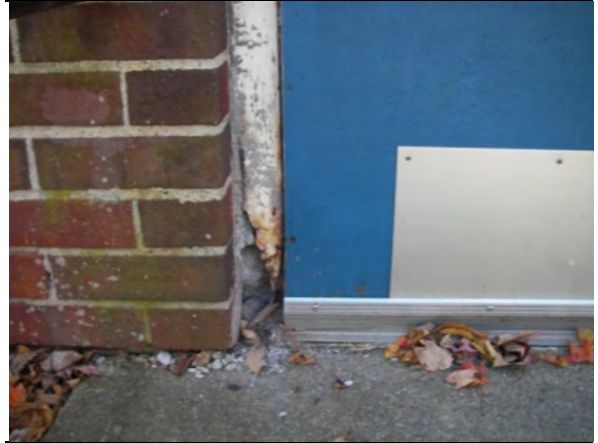
PHOTO #22: REAR BUILDING EXTENSION DOOR
AND DOOR FRAM DAMAGE

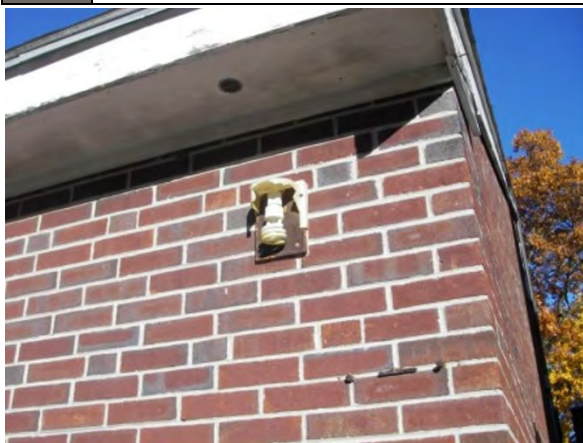
PHOTO #23: REAR BLDG EXT. DAMAGED WALL
PACK

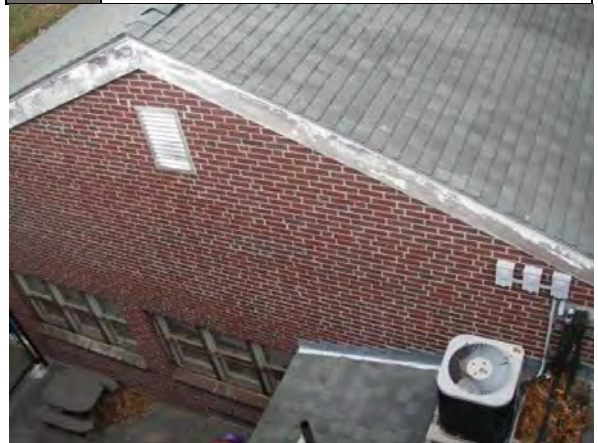
PHOTO #24: REAR BLDG EXT. ASPHALT ROOF
AND PEELING TRIM

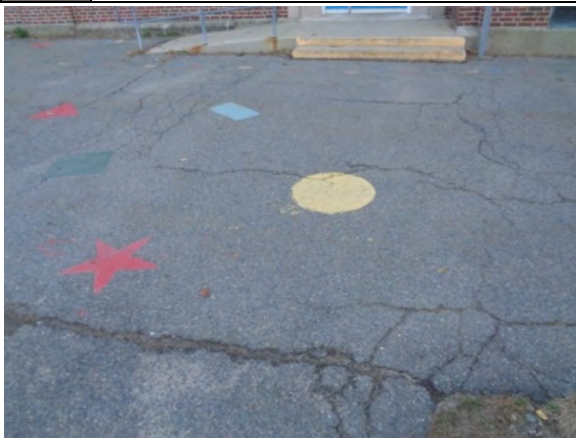
PHOTO #29: WEST PARKING LOT PAVEMENT CRACKING AND BREAKING UP

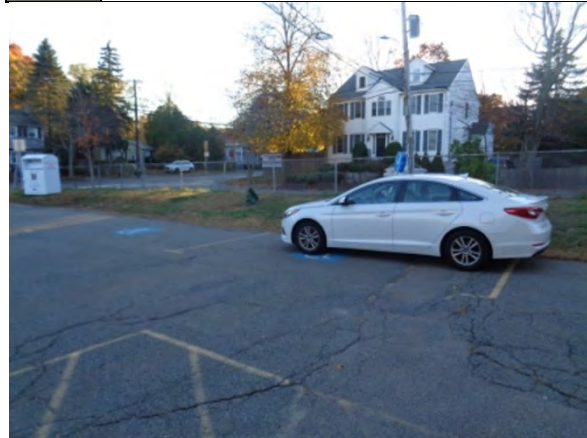
PHOTO #30: HANDICAP PARKING AND PAVEMENT IN DISREPAIR

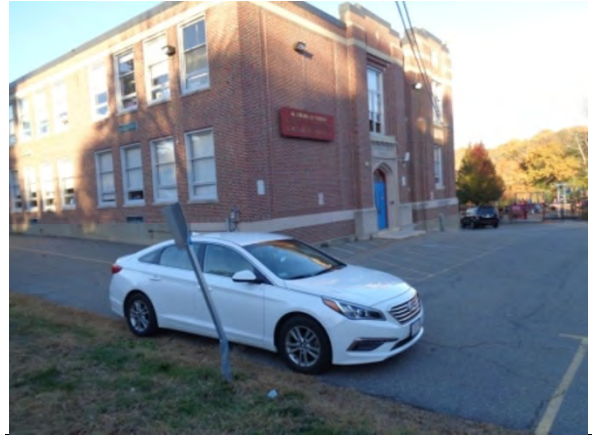
PHOTO #32: HANDICAP PARKING SIGN DAMAGED

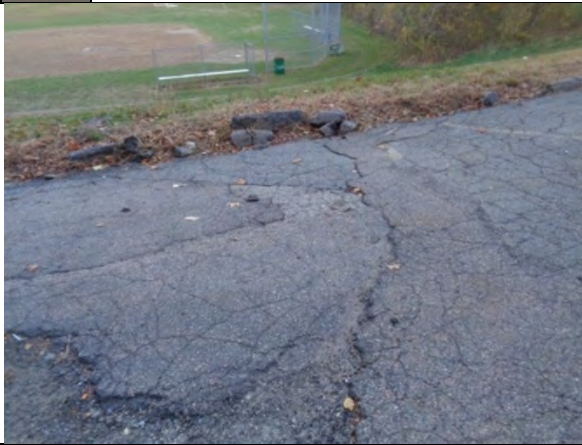
PHOTO #33: EAST SIDE PARKING LOT ASPHALT DETERIORATION

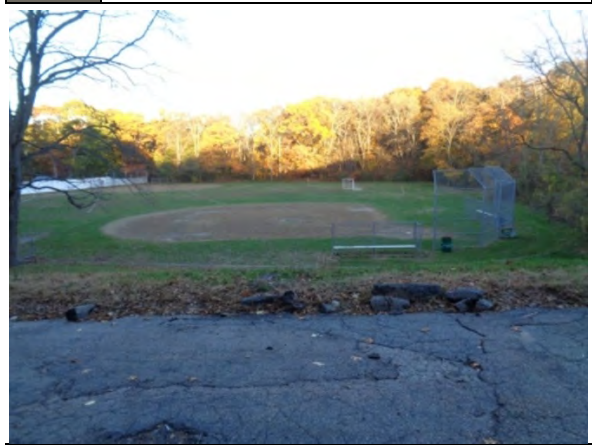
PHOTO #34: BASEBALL FIELD, BROKEN CURBS & DAMAGED PAVEMENT

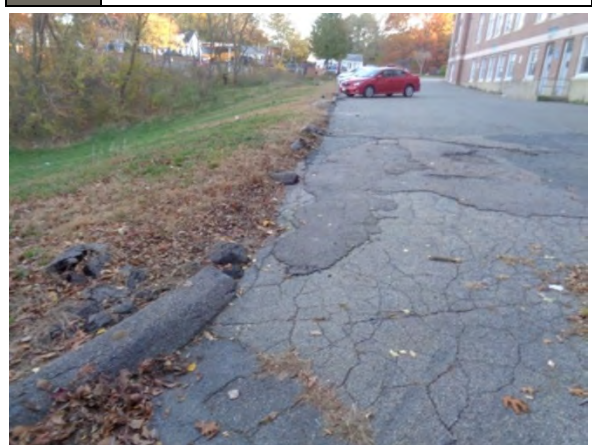
PHOTO #36: EAST SIDE PAVEMENT AND PARKING CURBS DAMAGE

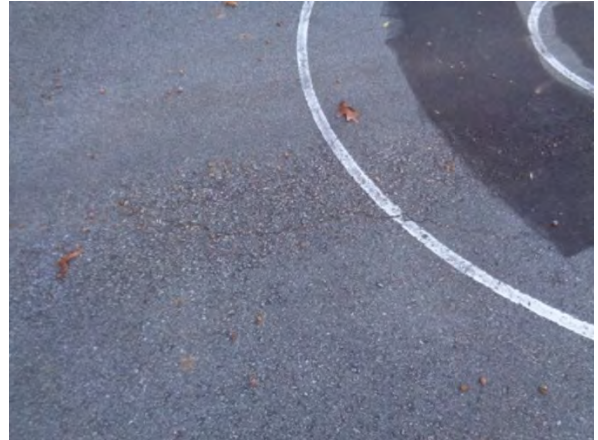
PHOTO #38: *BASKETBALL COURT BITUMINOUS SURFACE CRACKING & ROUGH*

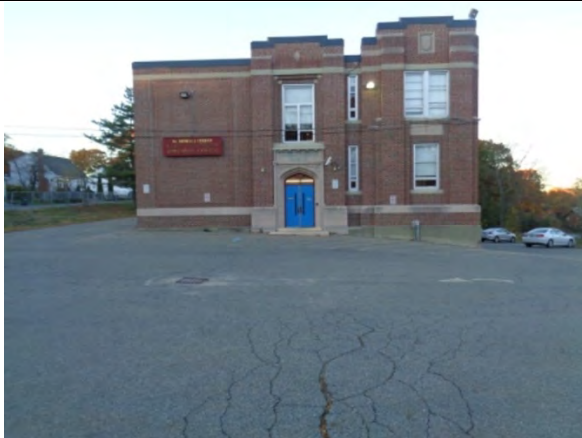
PHOTO #41: *SOUTH PARKING LOT POOR CONDITION*

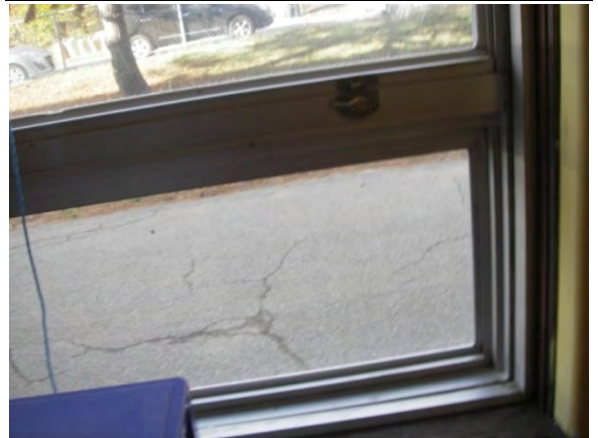
PHOTO #42: *WEST PARKING LOT POOR CONDITION*

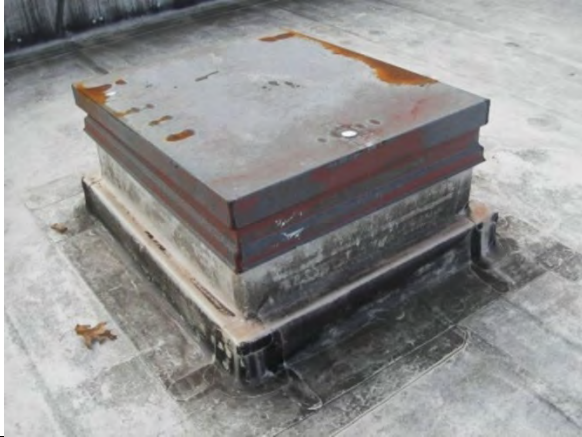
PHOTO #43: *RUSTED ROOF BILCO HATCH*

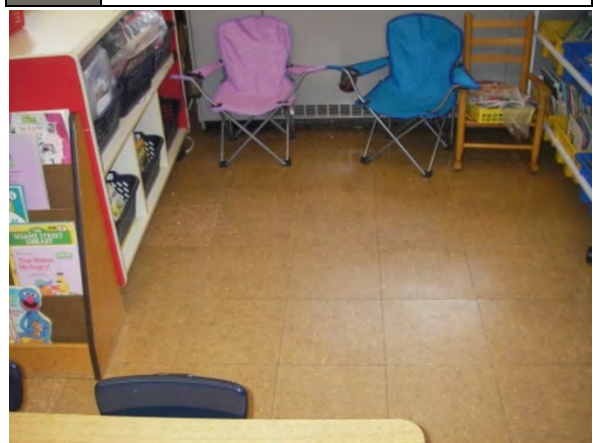
PHOTO #72: CLASSROOM SQUARE TILES ARE WELL WORN

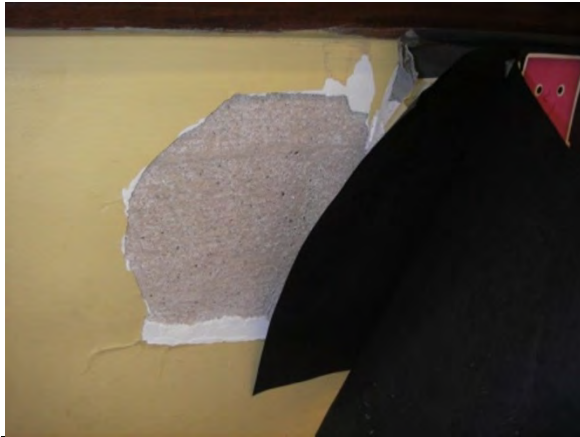
PHOTO #73: FIRST FLOOR CLASSROOM WALL PLASTER DAMAGE

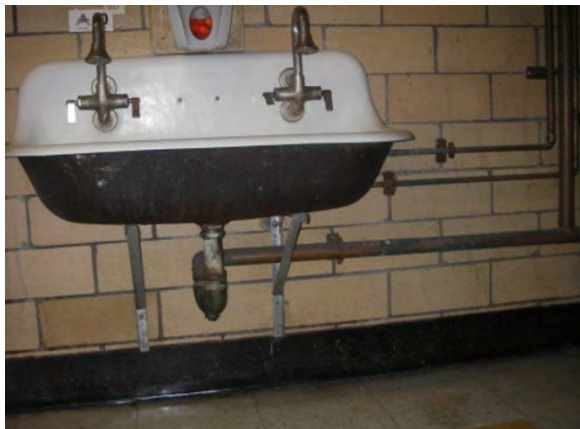
PHOTO #75: HALLWAY SINK WITH ANTIQUATED FIXTURES AND CORRODED PIPING

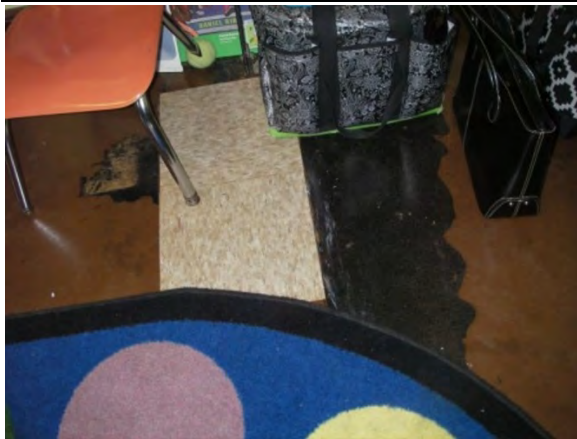
PHOTO #81: CLASSROOM FLOOR WORN AND PATCHED TILE

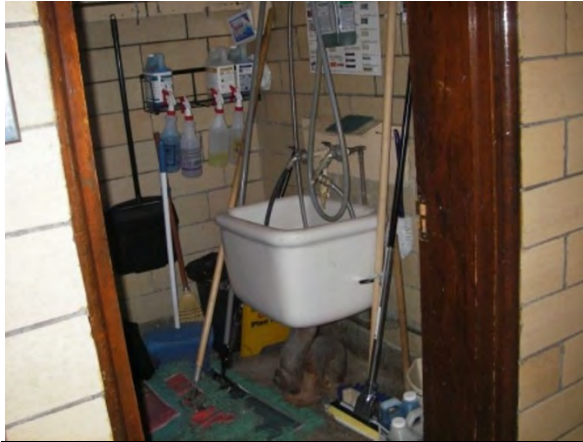
PHOTO #85: JANITOR'S CLOSET, NOTE CORRODED DRAIN PIPING

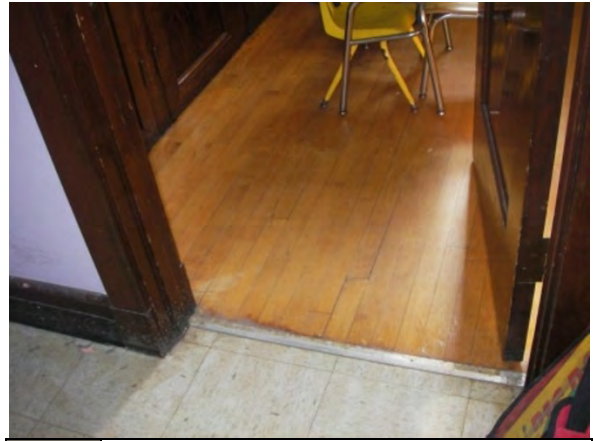
PHOTO #86: TEACHER'S ROOM TILE AND HARDWOOD FLOOR IS WORN

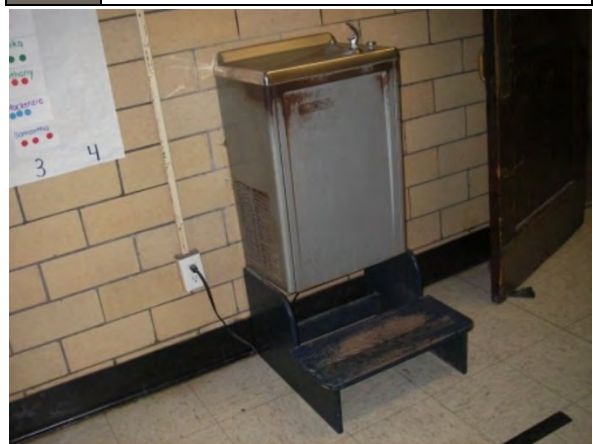
PHOTO #88: DRINKING FOUNTAIN IN POOR SHAPE-STEP IS TRIP HAZARD

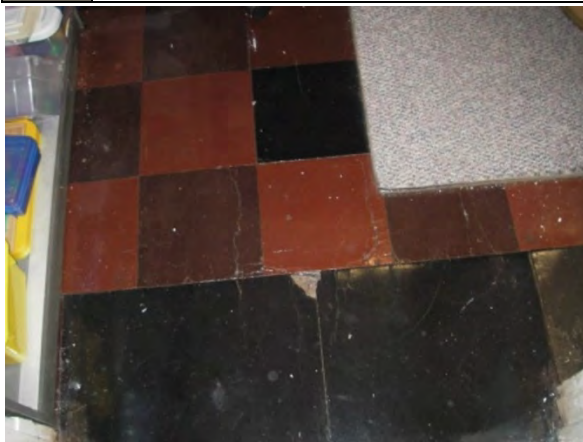
PHOTO #89: CLASSROOM FLOOR TILE IN POOR CONDITION

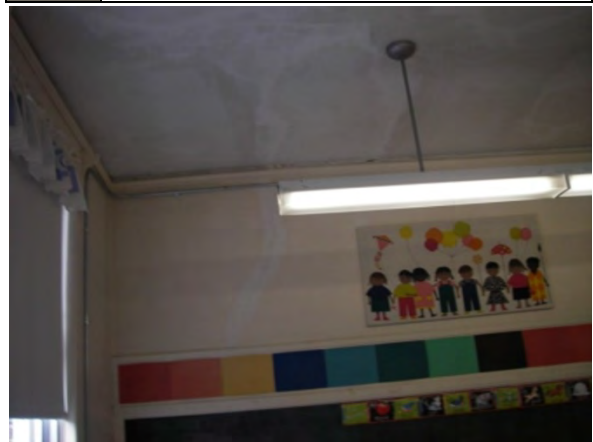
PHOTO #90: CLASSROOM WATER STAINS FROM LEAKS

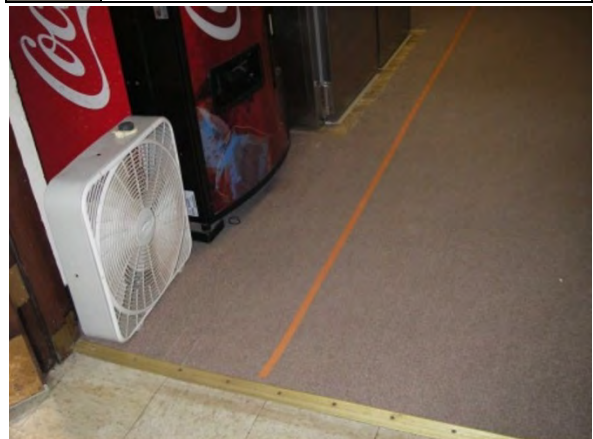
PHOTO #96: BASEMENT HALL CARPET INSTALLED OVER WORN FLOOR

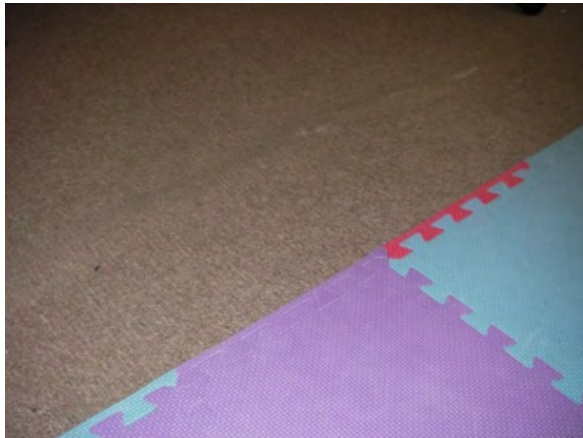
PHOTO #97: BASEMENT ART ROOM CARPET BUNCHED AND WORN

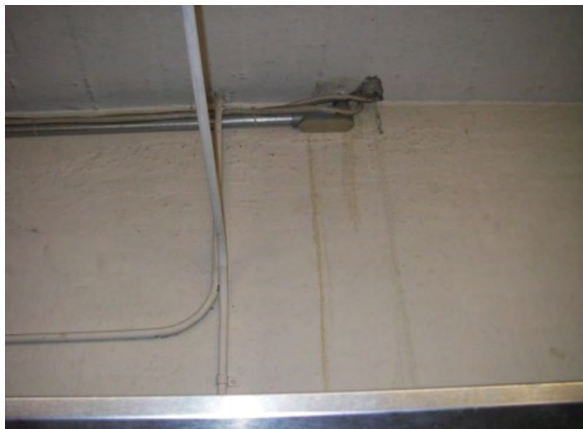
PHOTO #99: LEAK NEAR ART ROOM & BASEMENT REFRIGERATOR

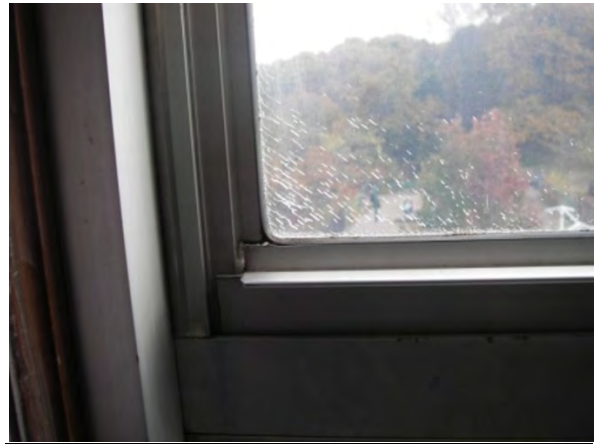
PHOTO #110: PLEXIGLASS REPLACED WINDOW CRACKING & GASKET OPENING

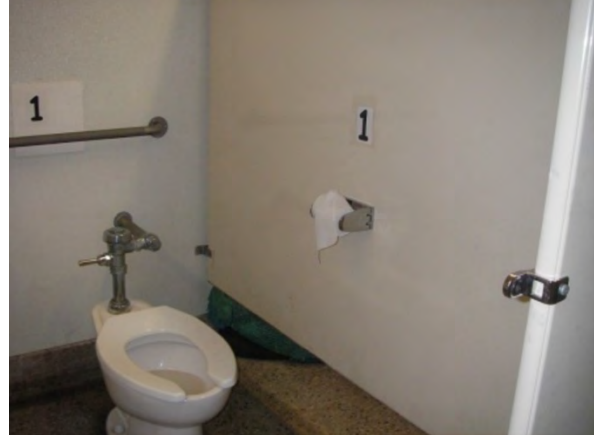
PHOTO #112: MISSING HANDICAPPED ACCESS HANDRAIL

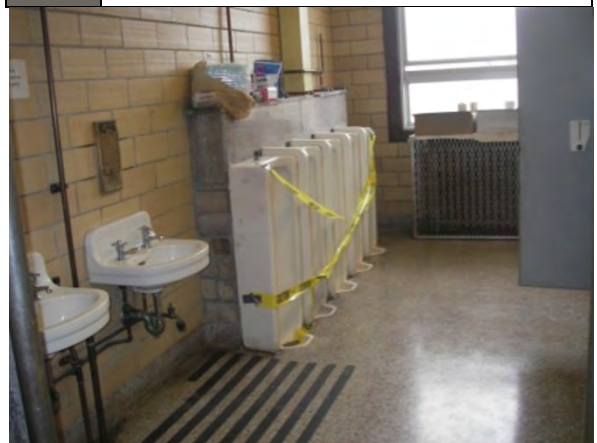
PHOTO #114: UNINALS NOT FUNCTIONING AND ABANDONED

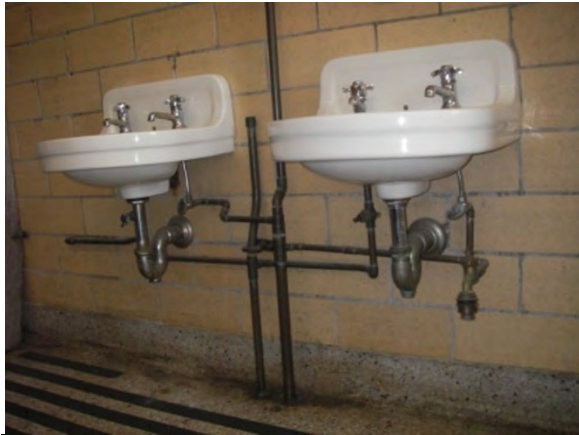
PHOTO #115: *ANTIQUATED RESTROOM SINKS & PIPES CORRODED*

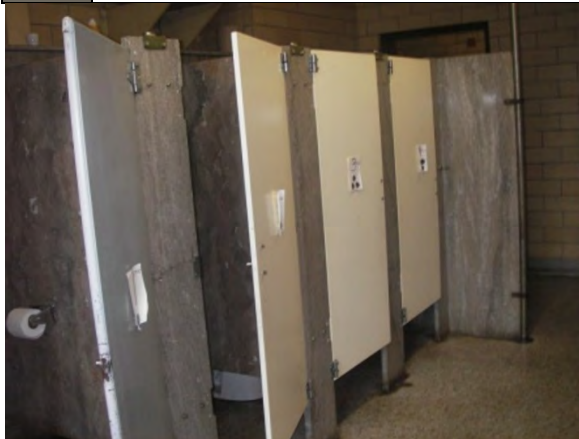
PHOTO #117: *RESTROOM STALL MATERIALS MIXED DUE TO MANY REPAIRS*

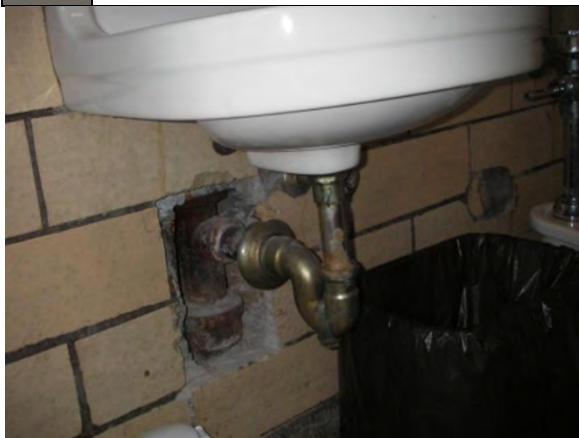
PHOTO #119: *CORRODED PLUMBING AND BRICK WALL IN NEED OF REPAIR*

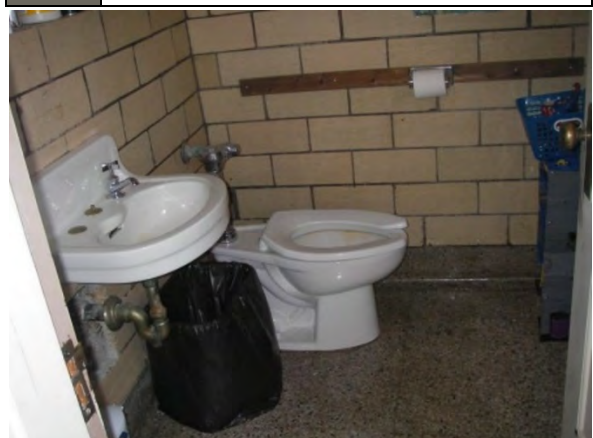
PHOTO #120: *RESTROOM IN POOR CONDITION*
