FACILITY CONDITION ASSESSMENT

FACILITY CONDITION ASSESSMENT
OF
DEDHAM-OAKDALE ELEMENTARY SCHOOL
147 CEDAR STREET
DEDHAM, MASSACHUSETTS 02026

EMG
10461 Mill Run Circle, Suite 1100
Owings Mills, Maryland 21117
800.733.0660
www.EMGcorp.com

December 27, 2016

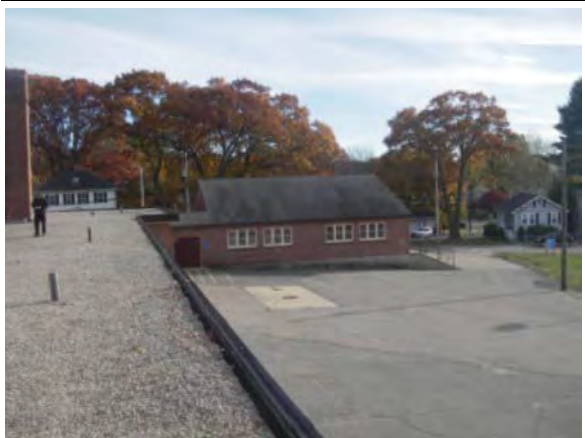
PHOTO #5: CLASSROOMS 14 AND 15, RUBBER ROOF WITH PEA STONE

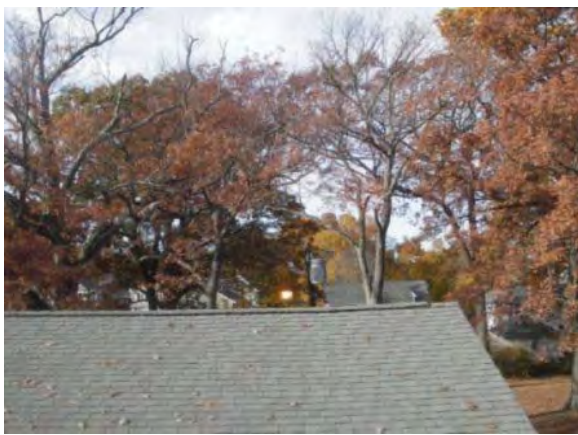
PHOTO #11: ROOF OF 1960 ADDITION ROOM 22, POLE LIGHT AND ELECTRIC SERVICE

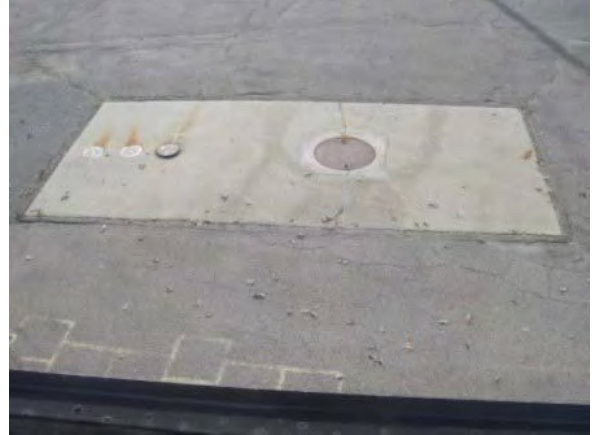
PHOTO #12: COURTYARD NO.2 FUEL OIL TANK COVER

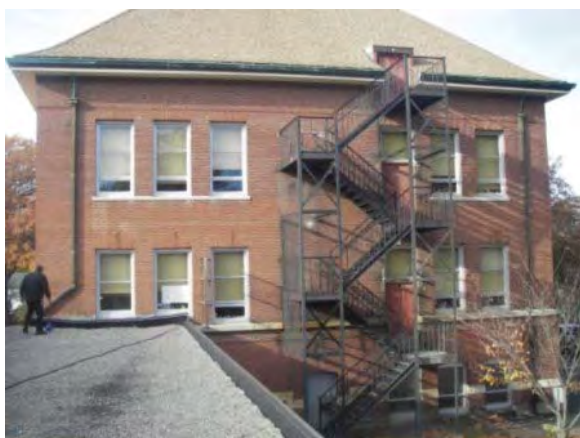
PHOTO #13: 1902 MAIN BUILDING SOUTH FIRE ESCAPE

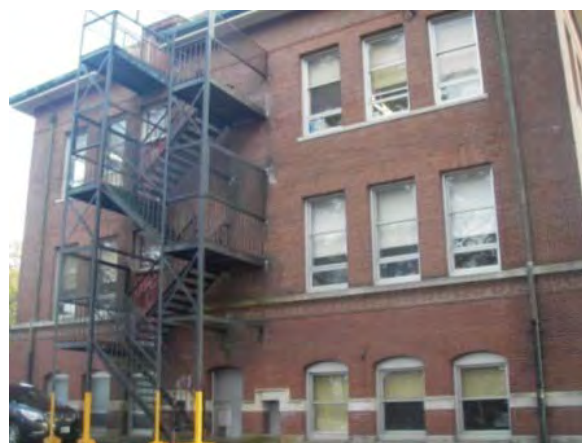
PHOTO #14: SOUTH SIDE OF MAIN BUILDING AND FIRE ESCAPE

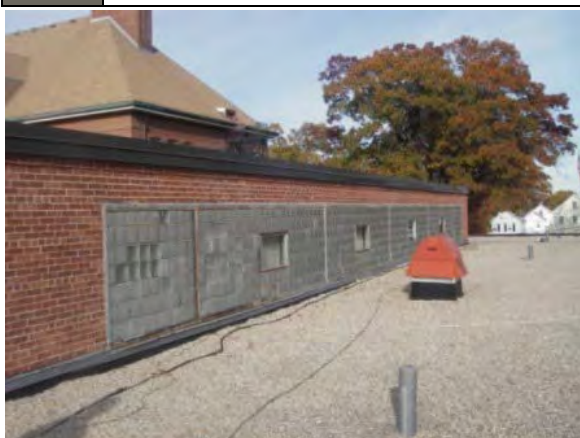
PHOTO #15: 1952 WING RUBBER ROOF AND PEA STONE LOOKING EAST AT GYM

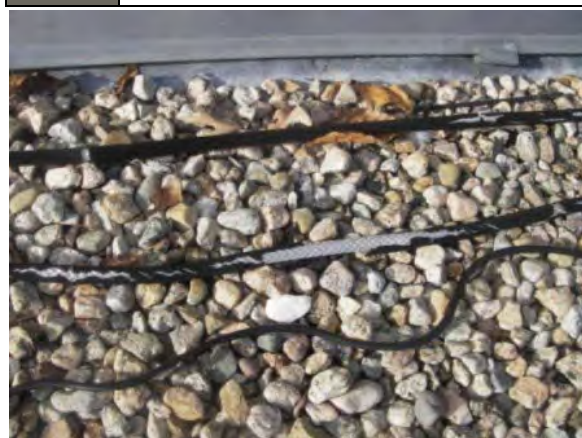
PHOTO #16: WIRING DROPPED ON ROOF AND INSULATION DISINTEGRATING

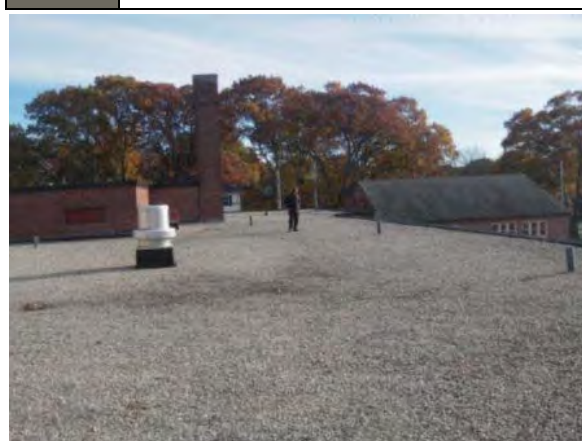
PHOTO #18: RUBBER AND PEA STONE ROOF ON THE 1952 WING LOOKING SOUTH

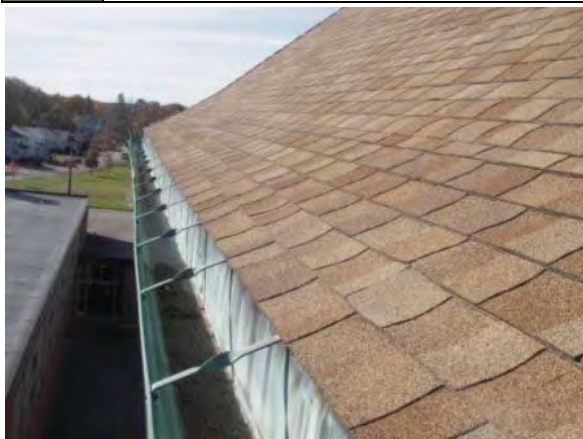
PHOTO #23: 1902 BUILDING ASPHALT SHINGLES AND COPPER GUTTER

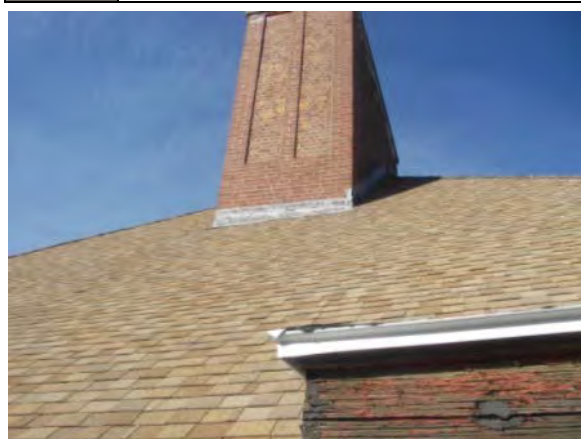
PHOTO #24: 1902 BUILDING CHIMNEY AND FIRE ESCAPE WALKOUT

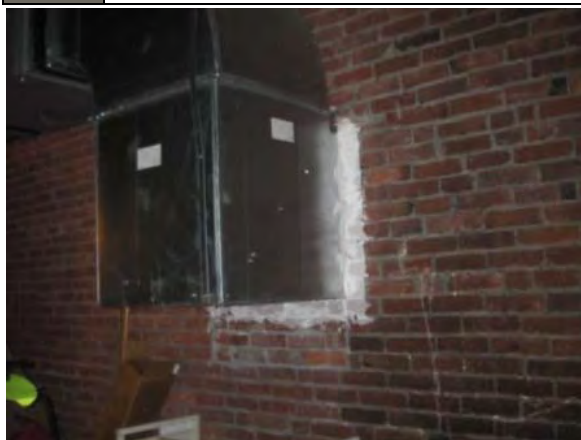
PHOTO #28: 1902 ATTIC EXHAUST VENT CONNECTED TO CHIMNEY

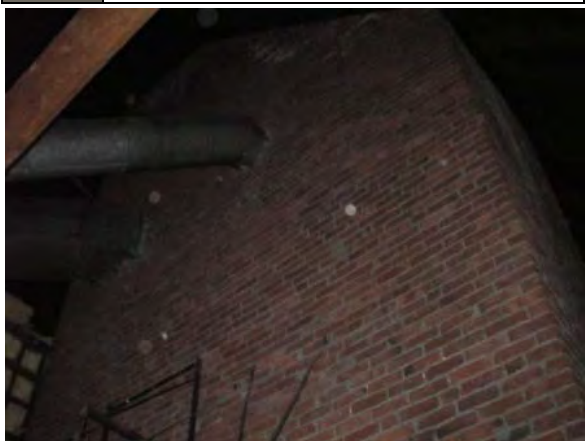
PHOTO #29: 1902 ATTIC ADDITIONAL EXHAUST VENTS TO CHIMNEY

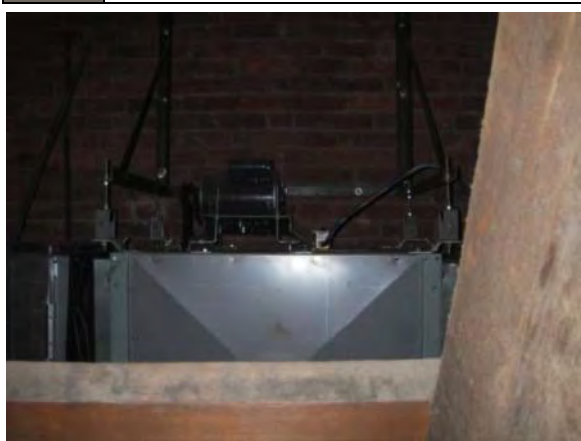
PHOTO #30: 1902 ATTIC EXHAUST FAN AND VENT DUCT

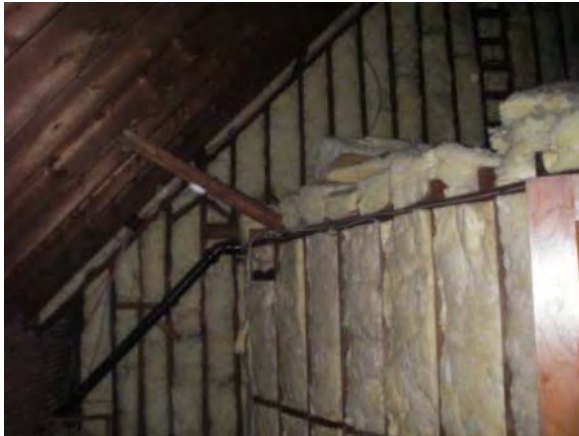
PHOTO #31: 1902 ATTIC INSULATION

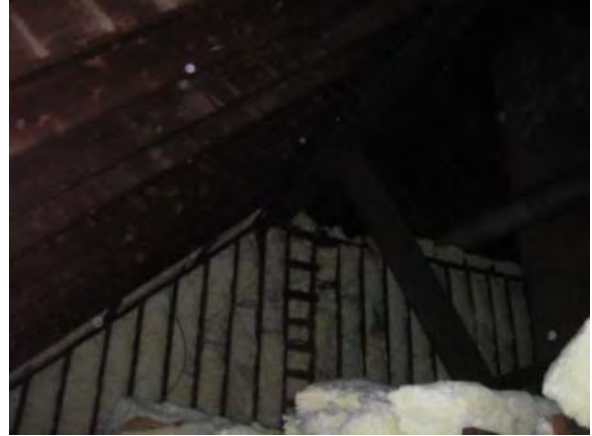
PHOTO #32: 1902 ATTIC INSULATION AND OUTER RAFTERS

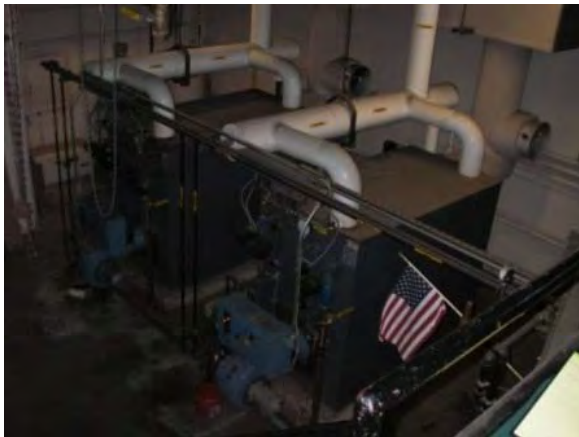
PHOTO #33: 1952 WING BOILER ROOM

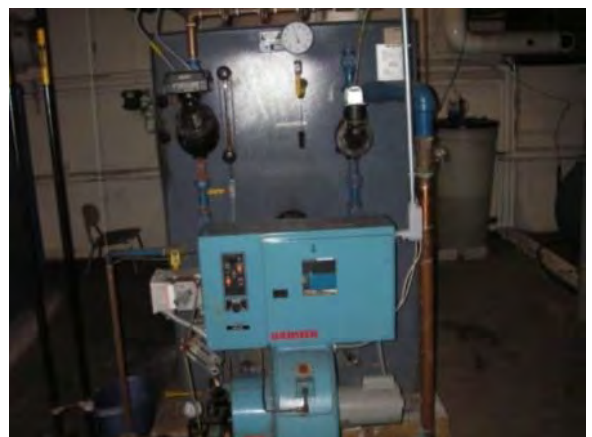
PHOTO #34: BOILER FRONT

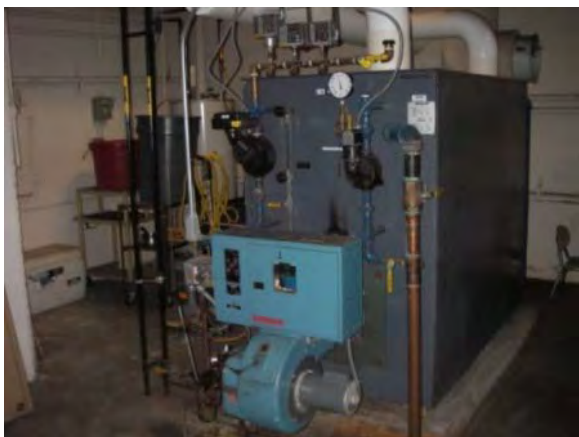
PHOTO #35: SECOND BOILER FRONT

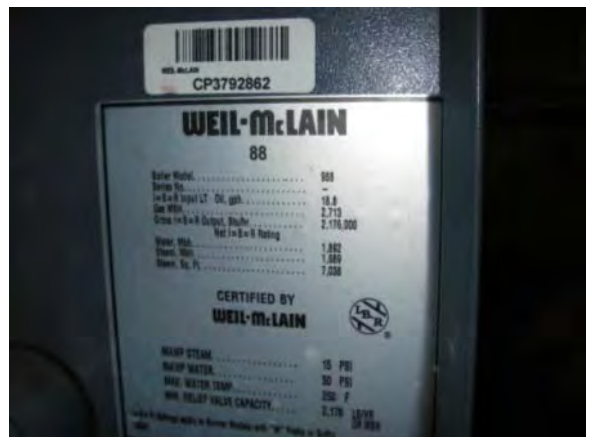
PHOTO #36: BOILER NAMEPLATE

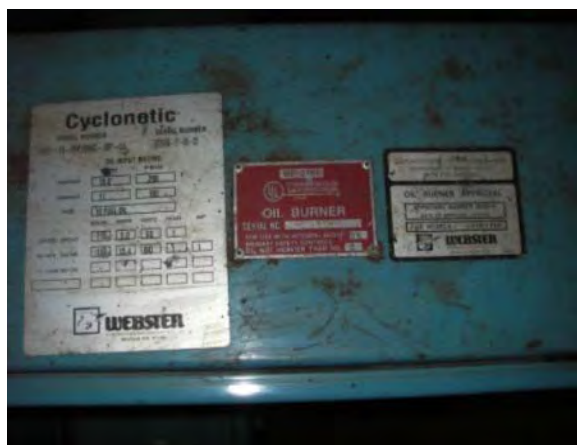
PHOTO #37: BURNER NAMEPLATE

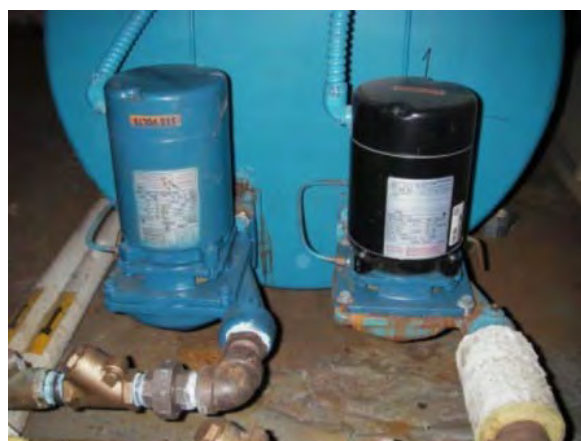
PHOTO #38: 1952 WING BOILER FEED PUMPS

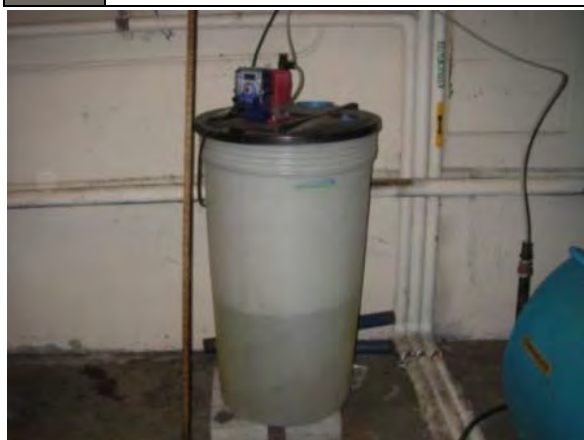
PHOTO #39: 1952 WING BOILER WATER TREATMENT SYSTEM

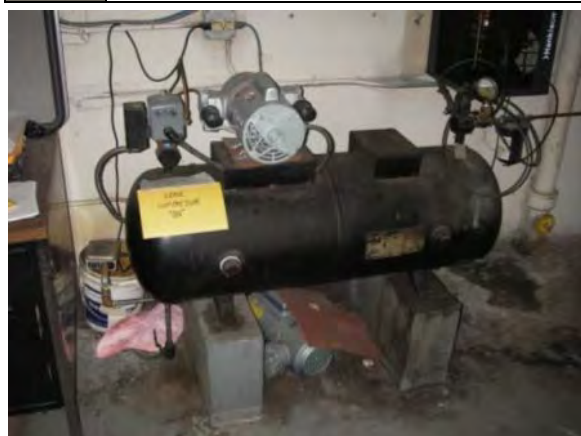
PHOTO #40: 1952 WING CONDENSATE AIR COMPRESSOR

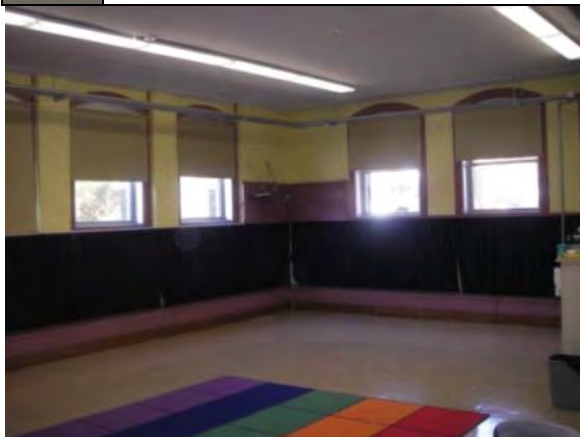
PHOTO #88: 1902 BUILDING ALUMINUM SINGLE-PANE WINDOW AND FRAME

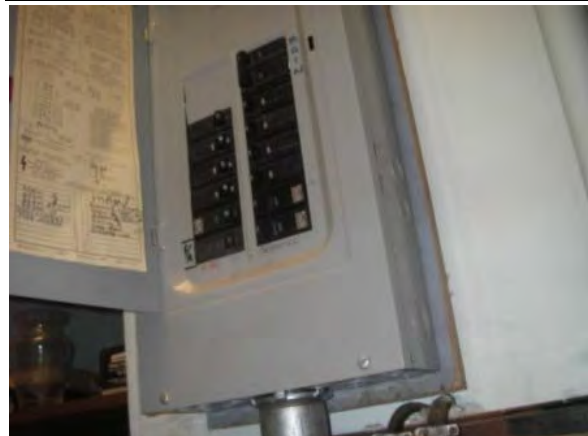
PHOTO #113: 1902 BUILDING OBSOLETE ELECTRICAL PANEL
