FACILITY CONDITION ASSESSMENT

FACILITY CONDITION ASSESSMENT
OF
DEDHAM – ECEC CAPEN SCHOOL
322 SPRAGUE STREET
DEDHAM, MASSACHUSETTS 02026

121711.16R000-005.322

December 12, 2016

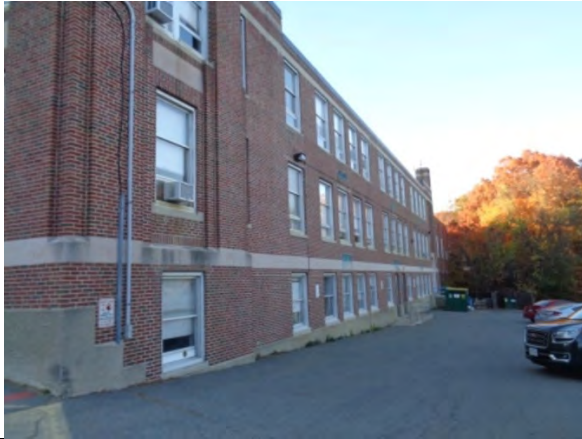
PHOTO #1: EAST EXTERIOR SIDE OF BUILDING

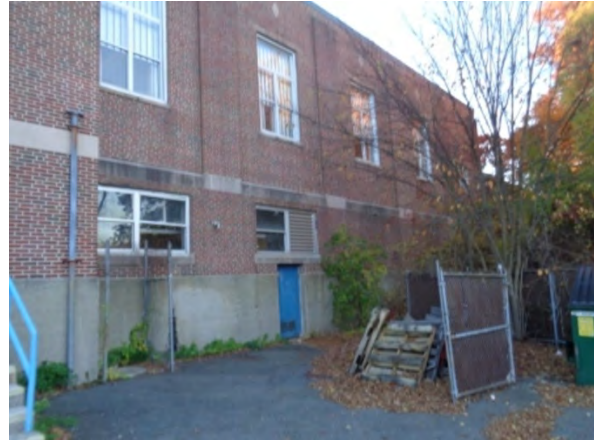
PHOTO #2: EXTERIOR SIDE OF BUILDING

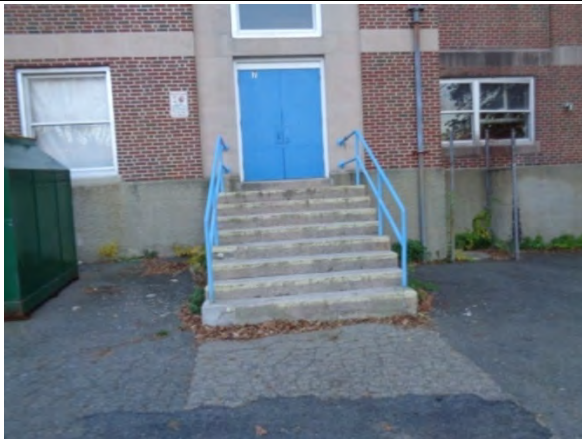
PHOTO #3: EAST SIDE, CENTRAL EXIT STAIRS

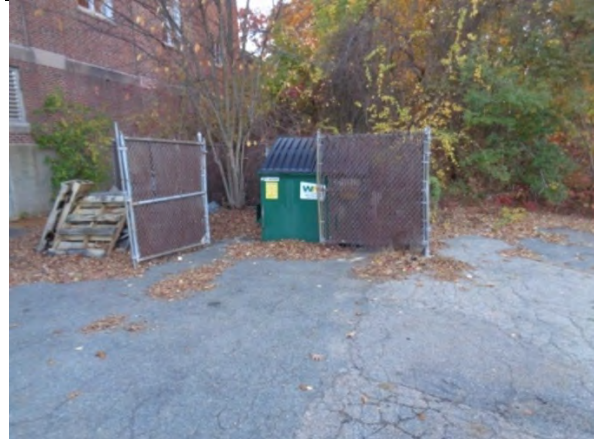
PHOTO #4: DUMPSTER A WITH FRONT FENCE ONLY

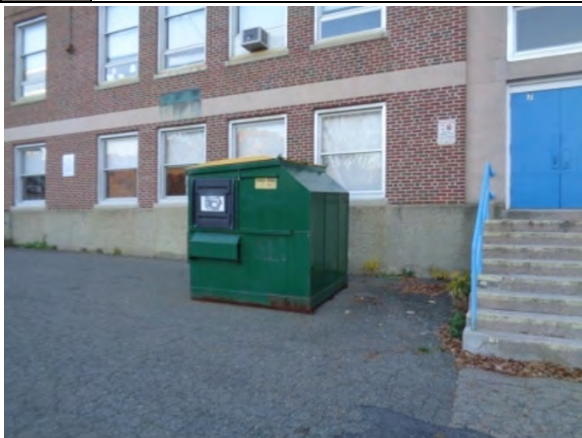
PHOTO #5: DUMPSTER B WITH NO FENCING

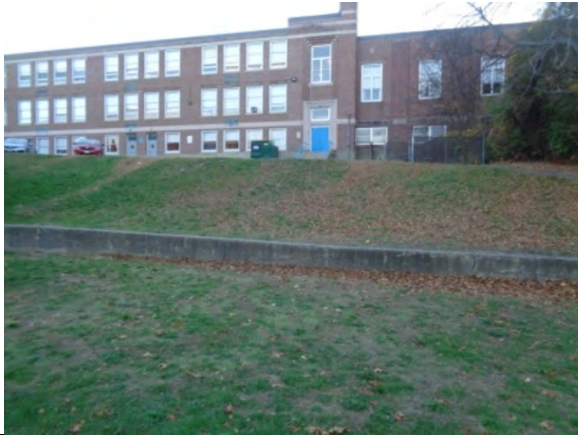
PHOTO #7: EAST FACE OF MAIN BUILDING & BASEBALL FIELD RETAINING WALL

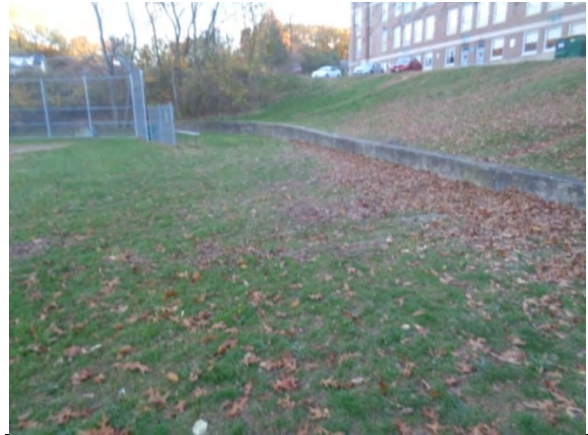
PHOTO #8: BASEBALL FIELD BACKSTOP AND RETAINING WALL

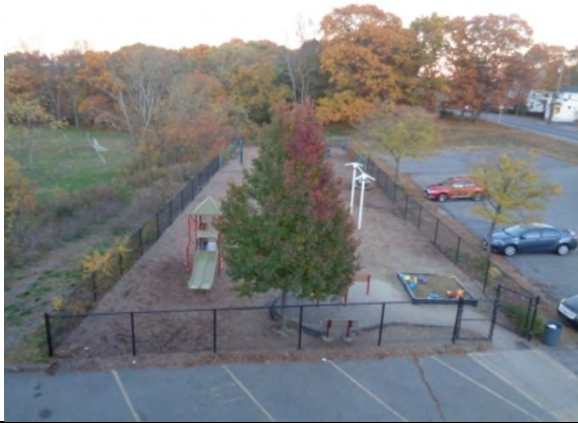
PHOTO #9: PLAYGROUND

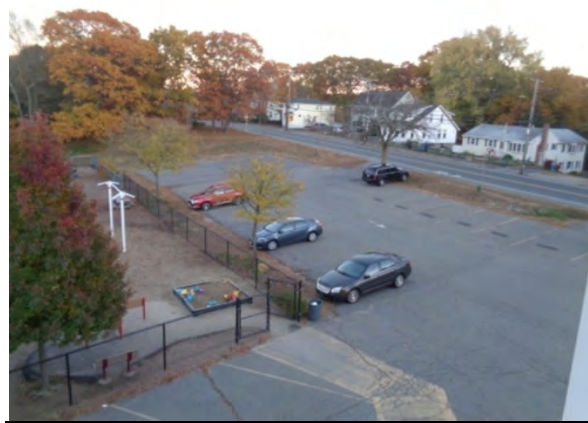
PHOTO #10: EAST END OF PARKING LOT

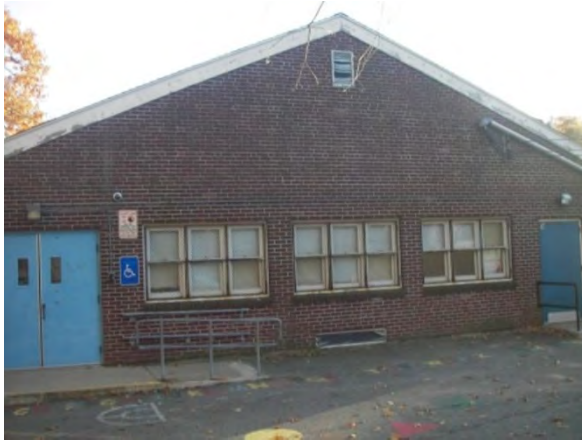
PHOTO #13: REAR BUILDING EXTENSION, NORTH SIDE

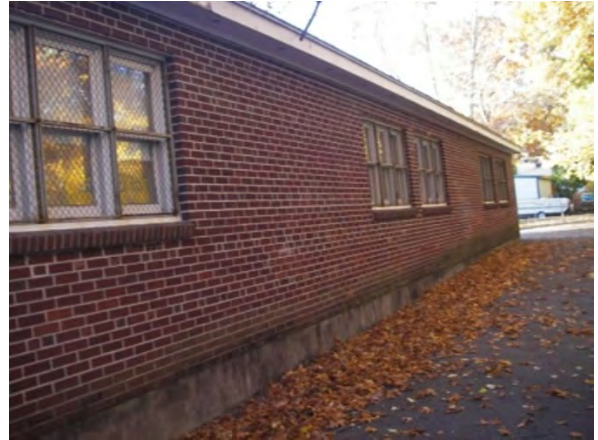
PHOTO #14: REAR BUILDING EXTENSION, EAST SIDE

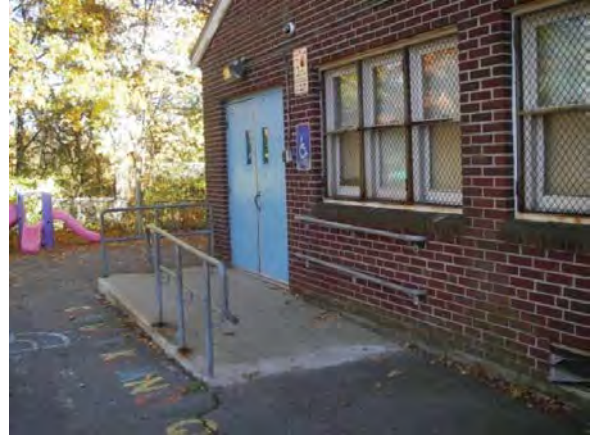
PHOTO #16: REAR BUILDING EXTENSION ACCESSIBLE RAMP

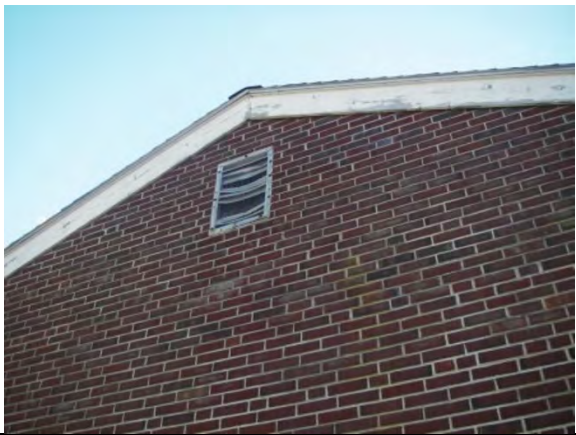
PHOTO #17: REAR BUILDING EXTENSION GABLE ROOF VENT IN DISREPAIR

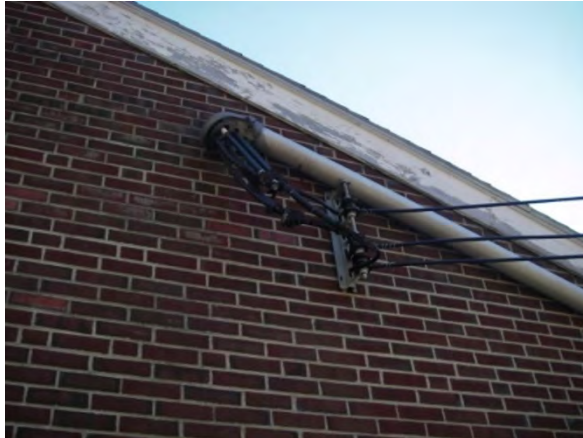
PHOTO #19: REAR BUILDING EXTENSION
ELECTRIC SERVICE

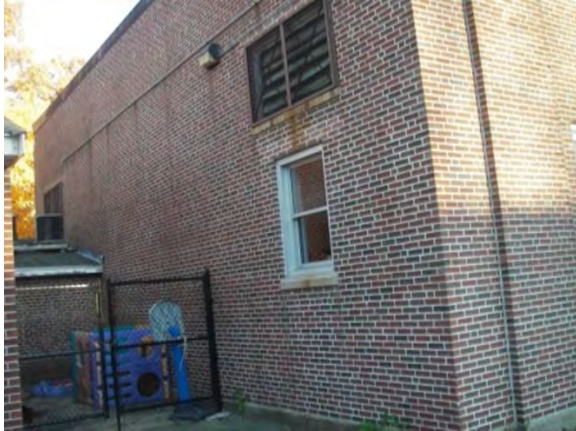
PHOTO #25: GYMNASIUM EXTERIOR, NORTH SIDE, ABANDONED AHU LOUVERS

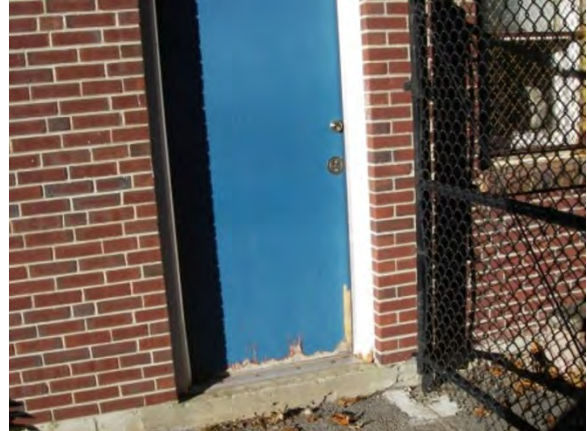
PHOTO #26: REAR BLDG EXT. ALLEY DOOR

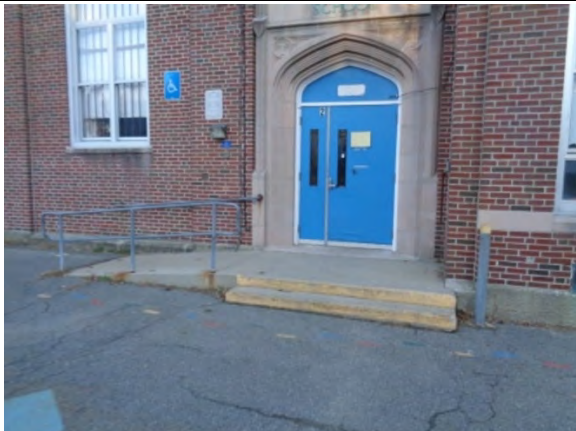
PHOTO #27: WEST ENTRANCE WITH HANDICAP RAMP AND RAILINGS

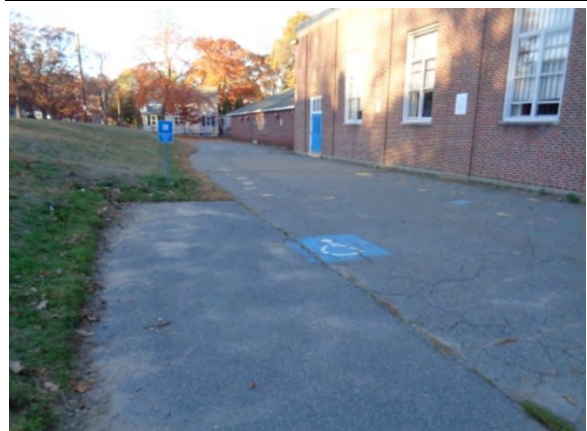
PHOTO #28: WEST SIDE SHOWING HANDICAP PARKING AND ENTRANCE

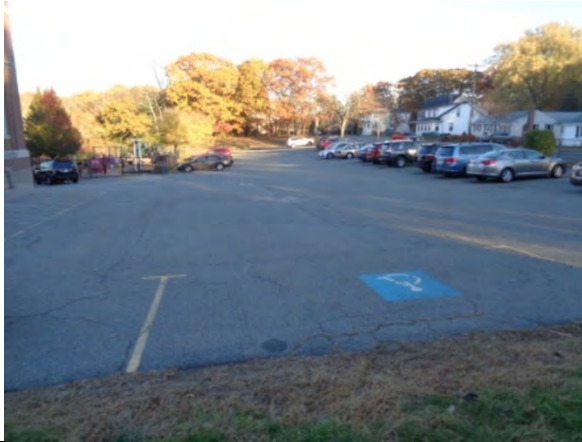
PHOTO #31: FRONT PARKING LOT LOOKING EAST

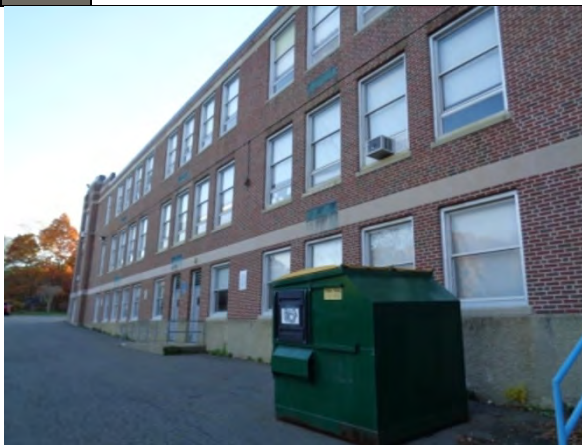
PHOTO #35: EAST SIDE EXTERIOR VIEW

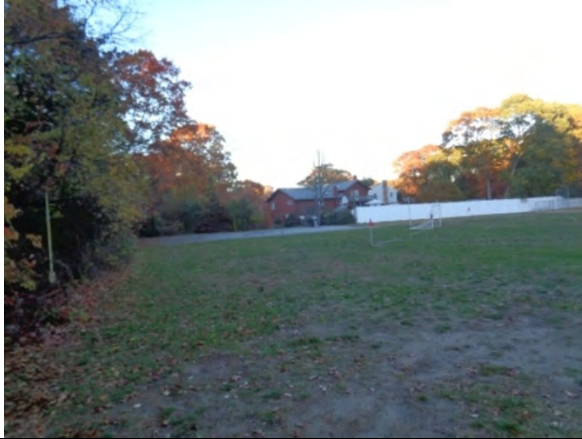
PHOTO #37: *PLAY FIELDS AND BASKETBALL COURT*

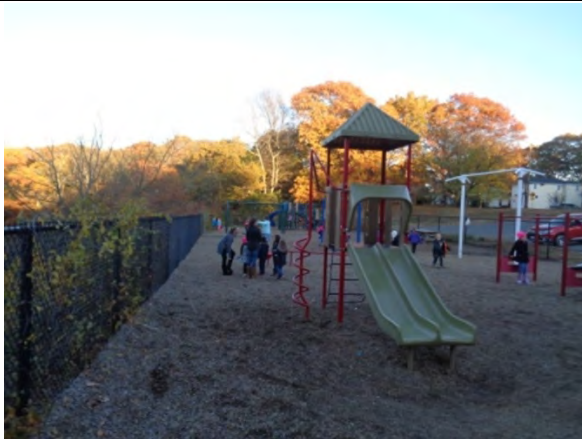
PHOTO #39: *PLAYGROUND*

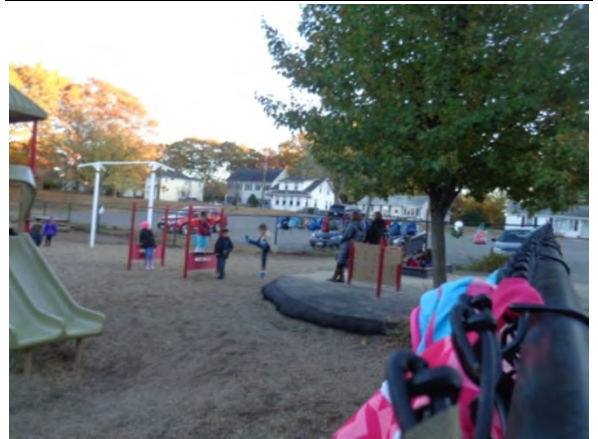
PHOTO #40: *PLAYGROUND WITH MINIMAL HANDICAPPED ACCESS*

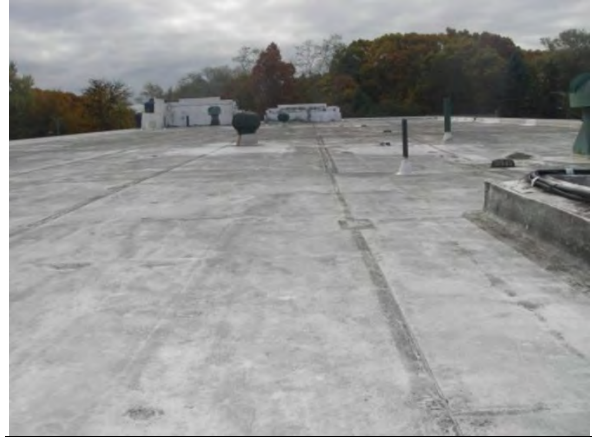
PHOTO #44: *ROOF MEMBRANE LOOKING SOUTH*

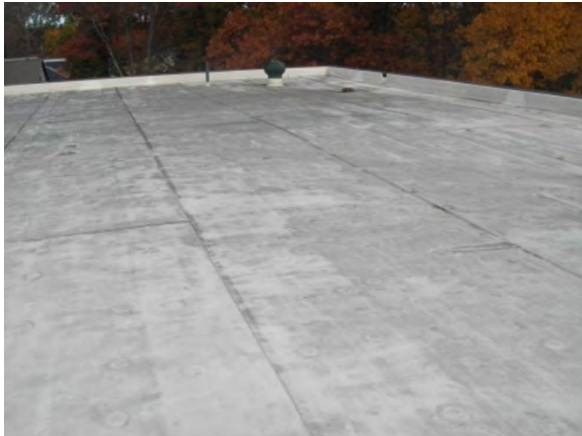
PHOTO #45: *ROOF MEMBRANE LOOKING NORTH*

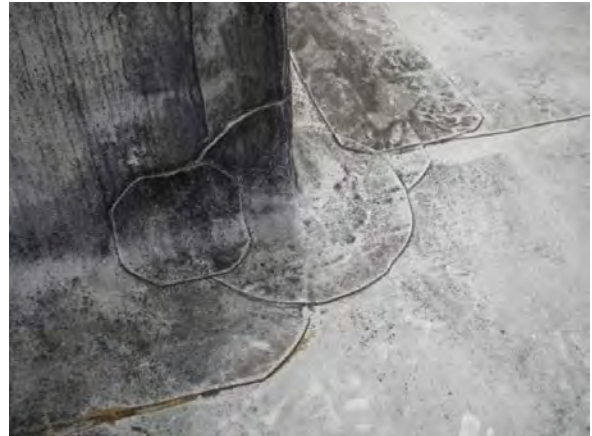
PHOTO #46: *ROOF MEMBRANE CORNER*

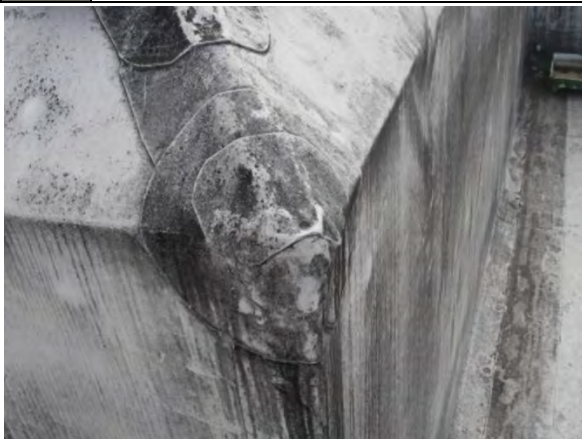
PHOTO #47: *ROOF MEMBRANE CORNER*

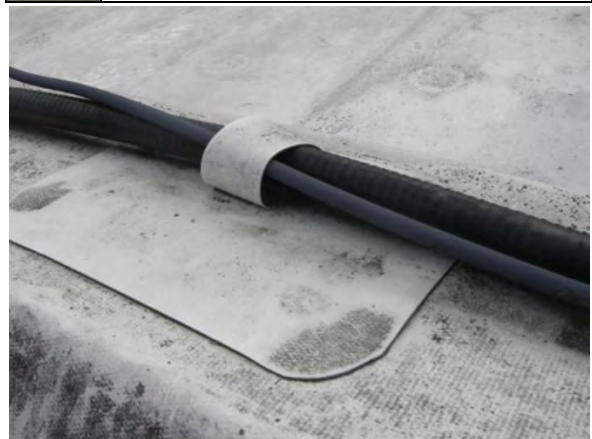
PHOTO #48: *ROOF MEMBRANE AND SECURED CABLES*

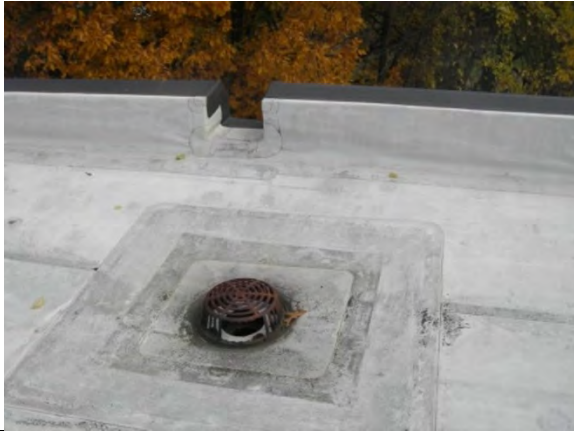
PHOTO #49: ROOF DRAIN AND PARAPET SCUPPER

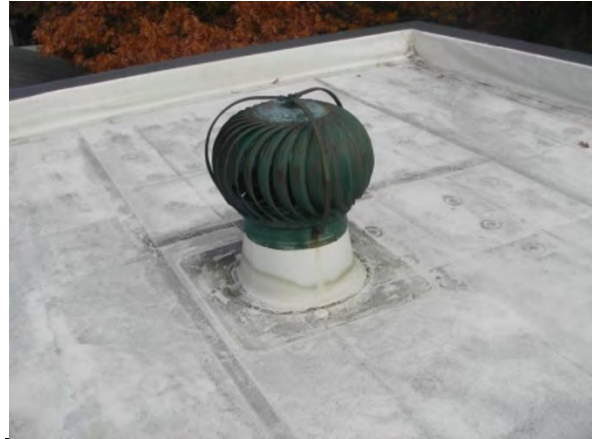
PHOTO #50: ROOF PASSIVE VENT COVER

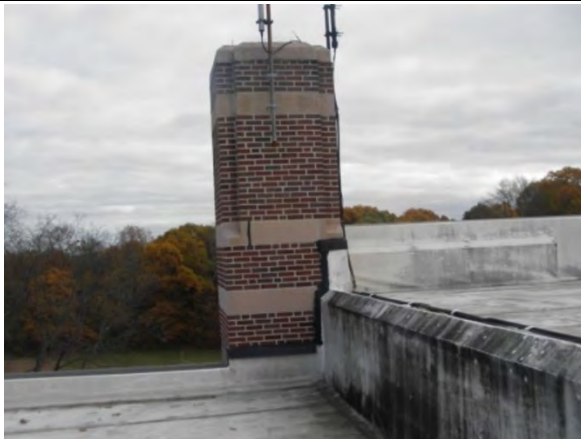
PHOTO #51: CHIMNEY

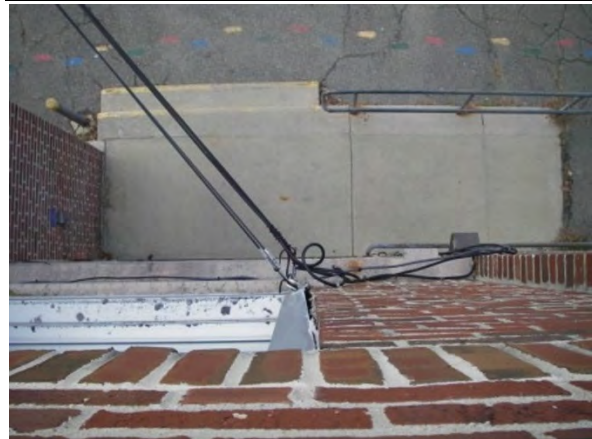
PHOTO #52: ELECTRIC SERVICE MESSENGER CABLE PULLING AWAY-WEST SIDE

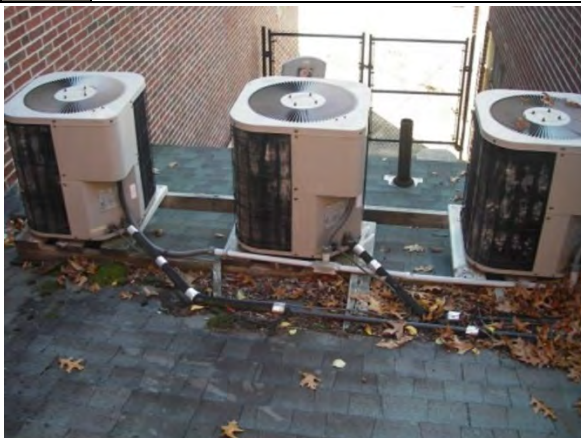
PHOTO #53: REAR BLDG EXT. SPLIT SYSTEM HEAT PUMPS

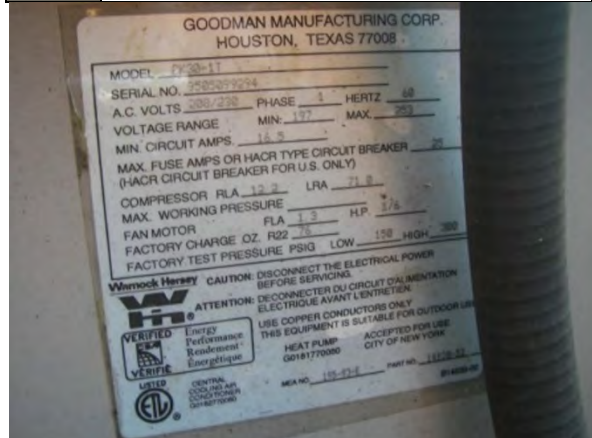
PHOTO #54: REAR BLDG EXT. SPLIT SYSTEM HEAT PUMP NAMEPLATE

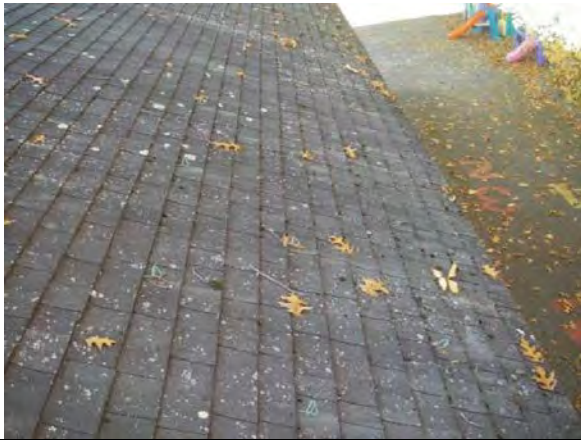
PHOTO #55: REAR BLDG EXT. ROOF

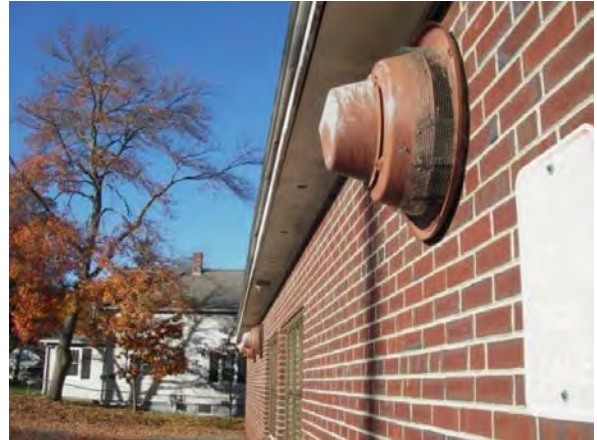
PHOTO #56: REAR BLDG EXT. CLASSROOM VENTILATION FANS

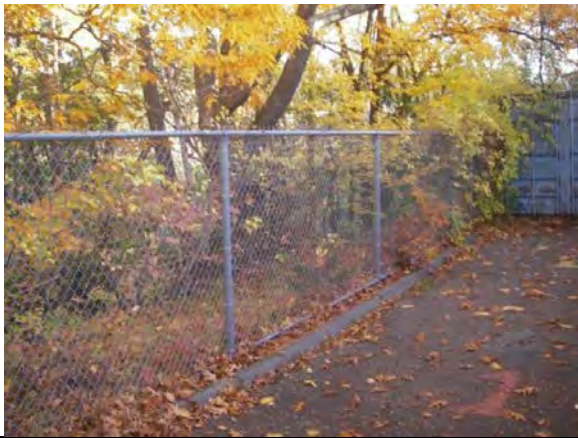
PHOTO #57: REAR BLDG EXT. EAST FENCE OVERGROWN

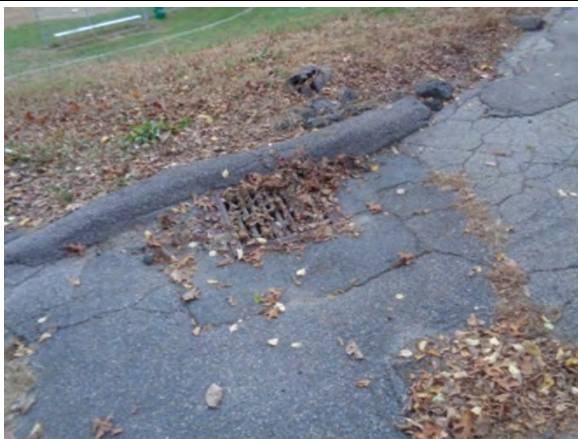
PHOTO #59: STORM DRAIN

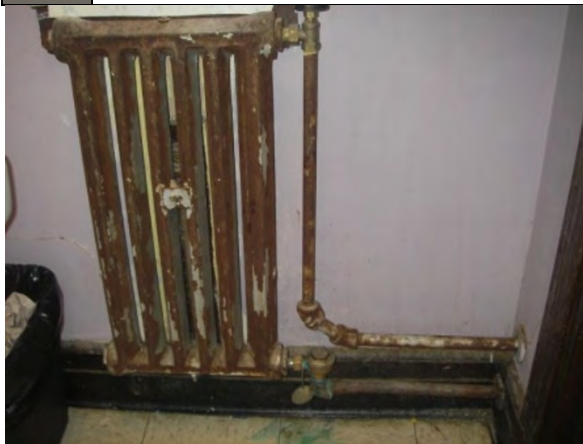
PHOTO #87: ORIGINAL RADIATOR

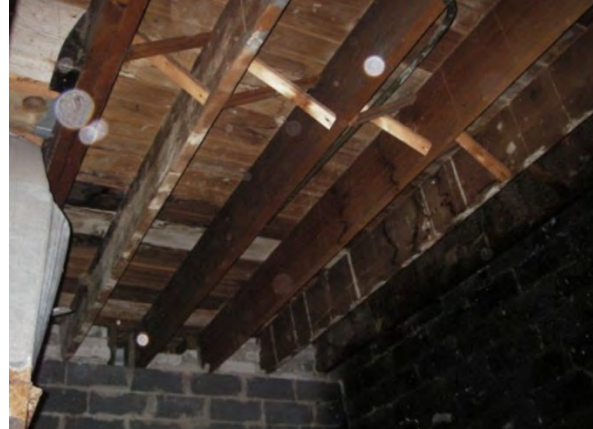
PHOTO #100: WOODEN JOISTS AND FLOORING

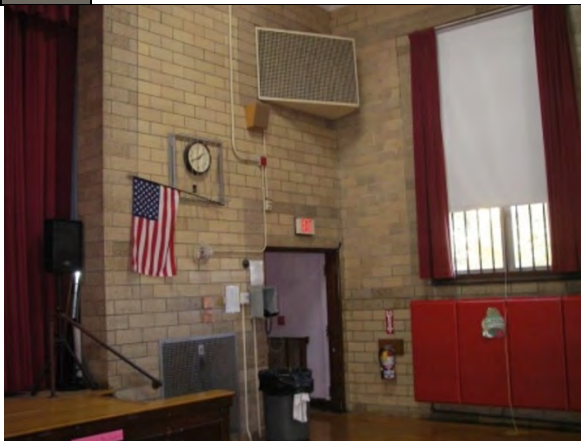
PHOTO #105: GYM ABANDONED AIR HANDLER VENT OPENINGS

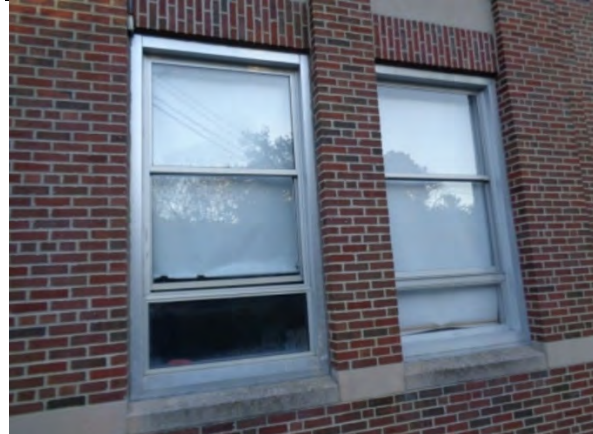
PHOTO #108: ALLUMINUM FRAME AND SASH SINGLE PANE WINDOWS

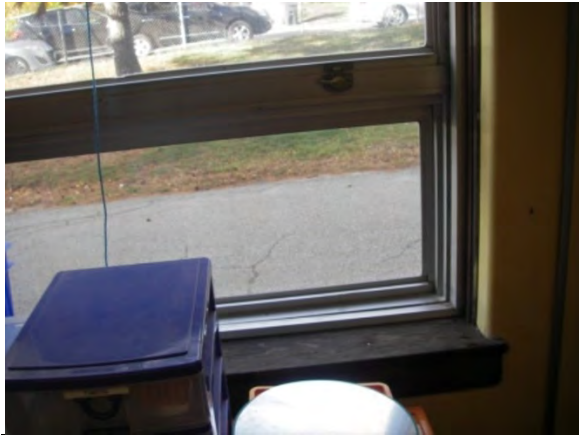
PHOTO #109: WINDOW

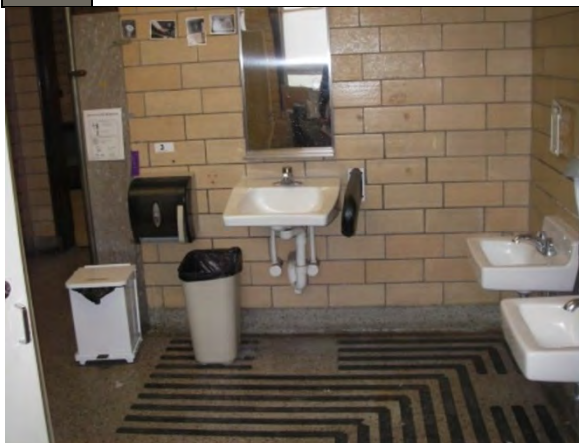
PHOTO #113: WHEELCHAIR TURNAROUND SPACE IS ADEQUATE

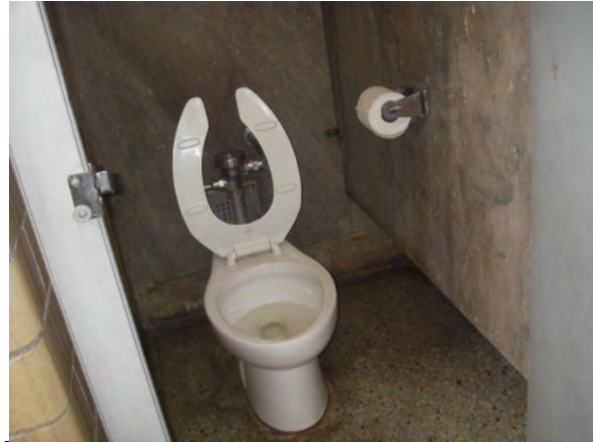
PHOTO #116: *TYPICAL 1.6 GALLONS PER FLUSH TOILET*

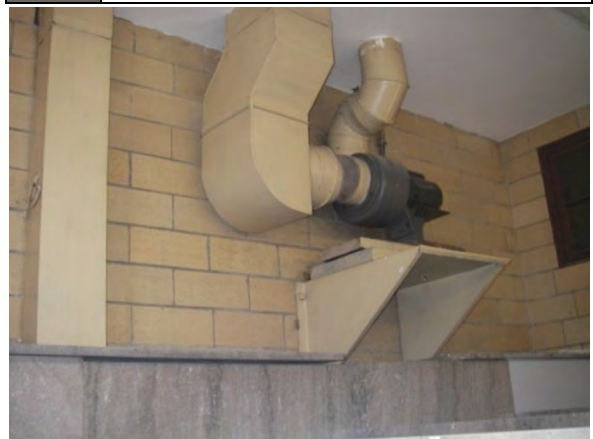
PHOTO #118: *ORIGINAL FAN VENTILATION IN RESTROOM*

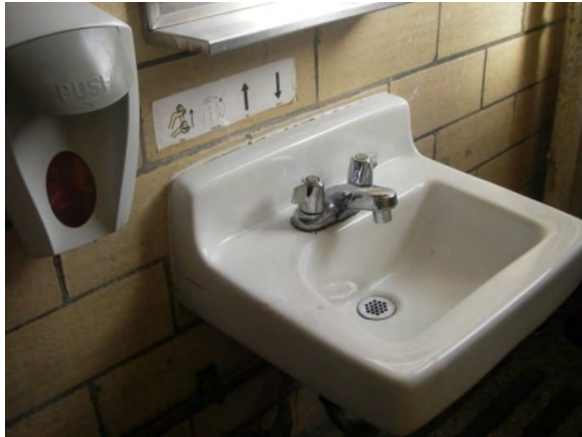
PHOTO #121: STANDARD SINK WITH 0.5GPM AERATOR

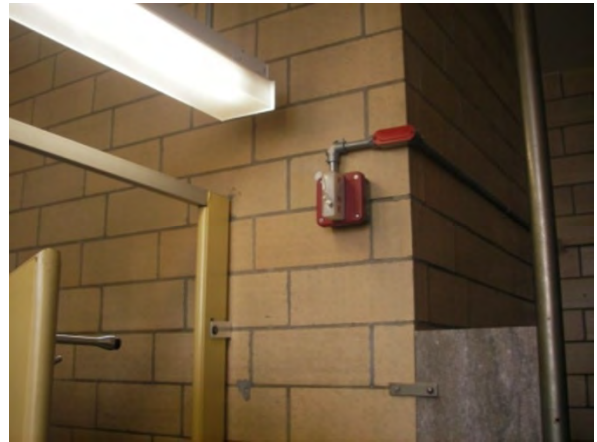
PHOTO #122: FIRE ALARM ANNUNCIATOR IN RESTROOM

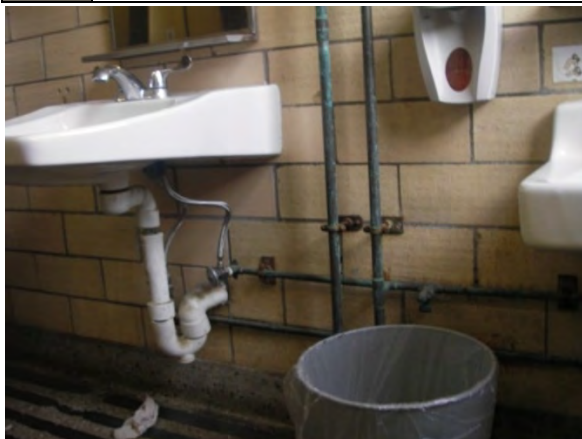
PHOTO #123: DRAIN PIPING IS PROTECTED PROPERLY

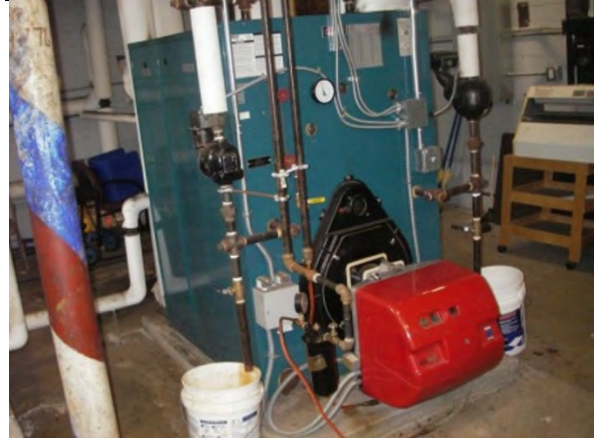
PHOTO #126: BOILER 1 NEW IN 2011

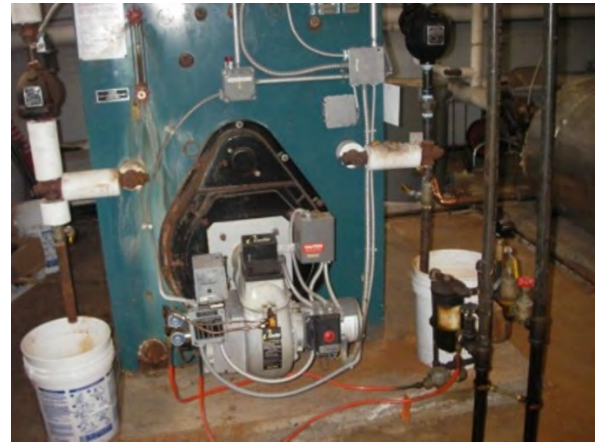
PHOTO #128: BOILER 2 NEW IN 1998

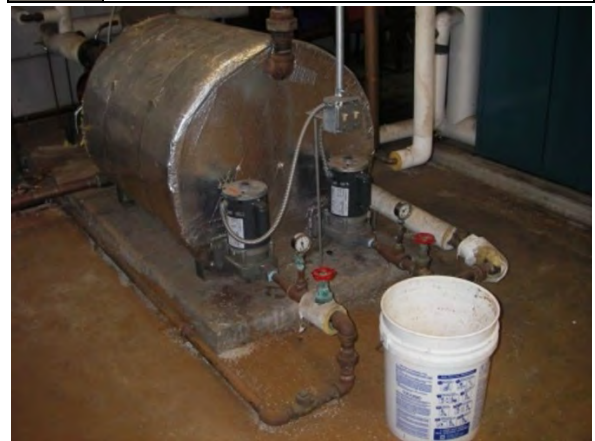
PHOTO #132: BOILERS HOT WATER TANK AND HOT WATER CIRCULATION PUMPS

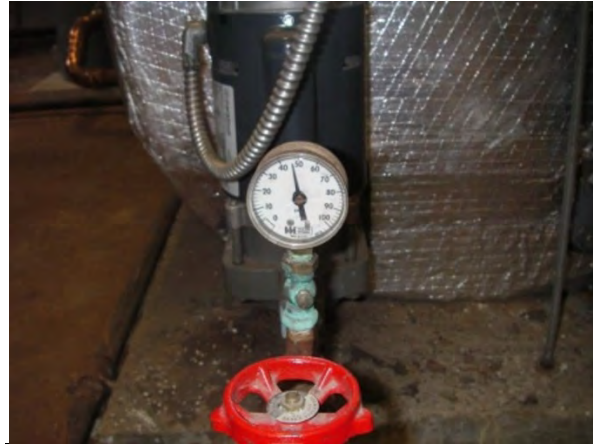
PHOTO #134: HOT WATER SYSTEM BOOSTED TO ABOUT 46 PSI

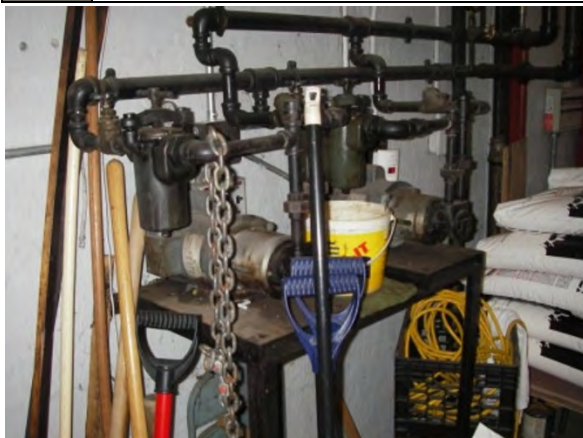
PHOTO #137: DUAL PARALLEL FUEL OIL PUMPS

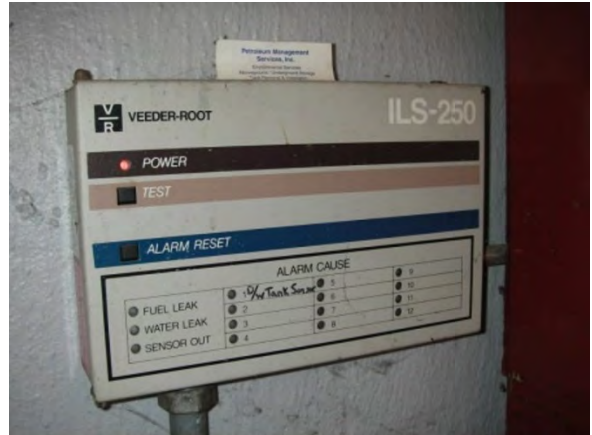
PHOTO #144: NO.2 FUEL OIL UNDERGROUND TANK MONITORING SYSTEM

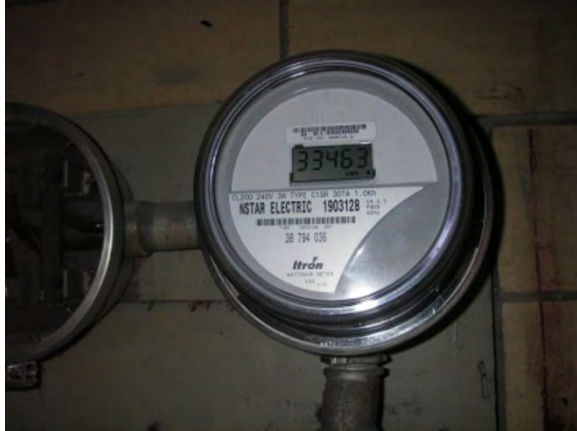
PHOTO #145: ELECTRIC SERVICE METER, 400A, 120/240V

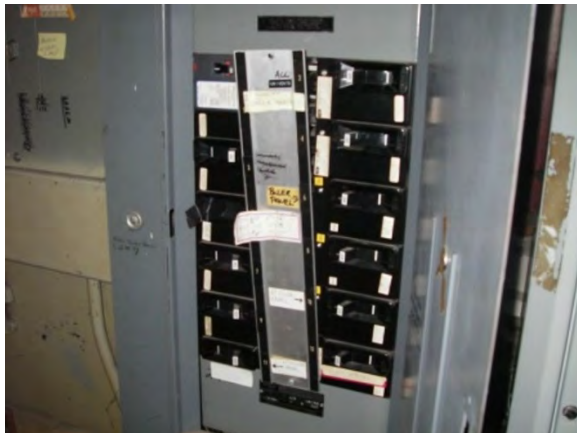
PHOTO #147: 400AMP SERVICE MAIN DISTRIBUTION PANEL-OBSOLETE

ECEC Capen School	7.4	514586	D5012 Distribution Panel, 208 Y, 120 V, 400 Amp, Replace	1	EA	\$9,487.85	\$9,488	\$9,488
ECEC Capen School	8.1	514696	C3024 Interior Floor Finish, Vinyl Tile (VCT), Replace	8000	SF	\$4.80	\$38,405	\$38,405
ECEC Capen School	8.1	514697	C3032 Interior Ceiling Finish, Acoustical Tile (ACT) Dropped Fiberglass, Replace	400	SF	\$5.05	\$2,019	\$2,019
Immediate Repairs Total								\$203,530

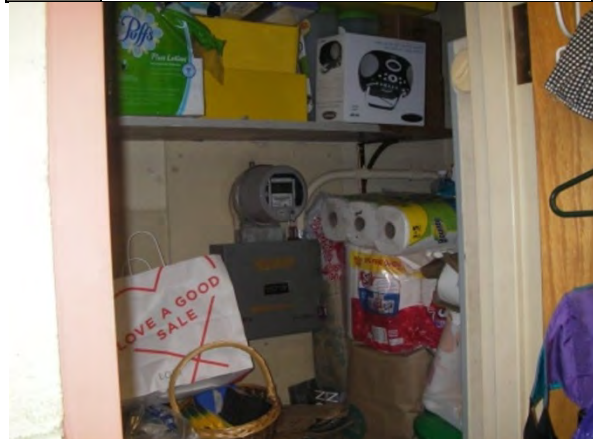
PHOTO #148: ELECTRIC SERVICE EQUIPMENT & METER IN CLASSROOM CLOSET

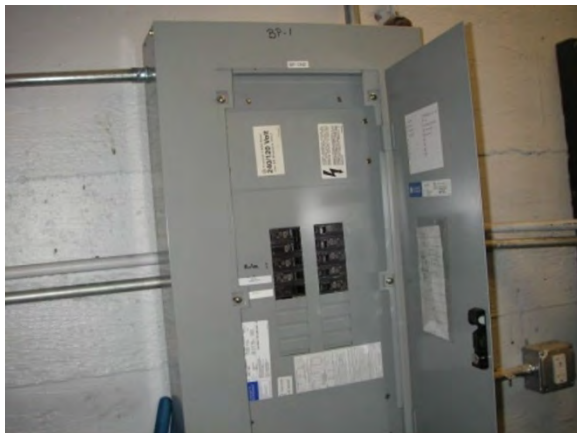
PHOTO #149: BOILER ROOM UPDATED ELECTRIC DISTRIBUTION PANEL
